KÁROLY BELÉNYESY, PhD

ARCHAEOLOGICAL EXPLORATION IN KOH KER, PRASAT KRACHAP TEMPLE AND SURROUNDINGS, 2014–2015

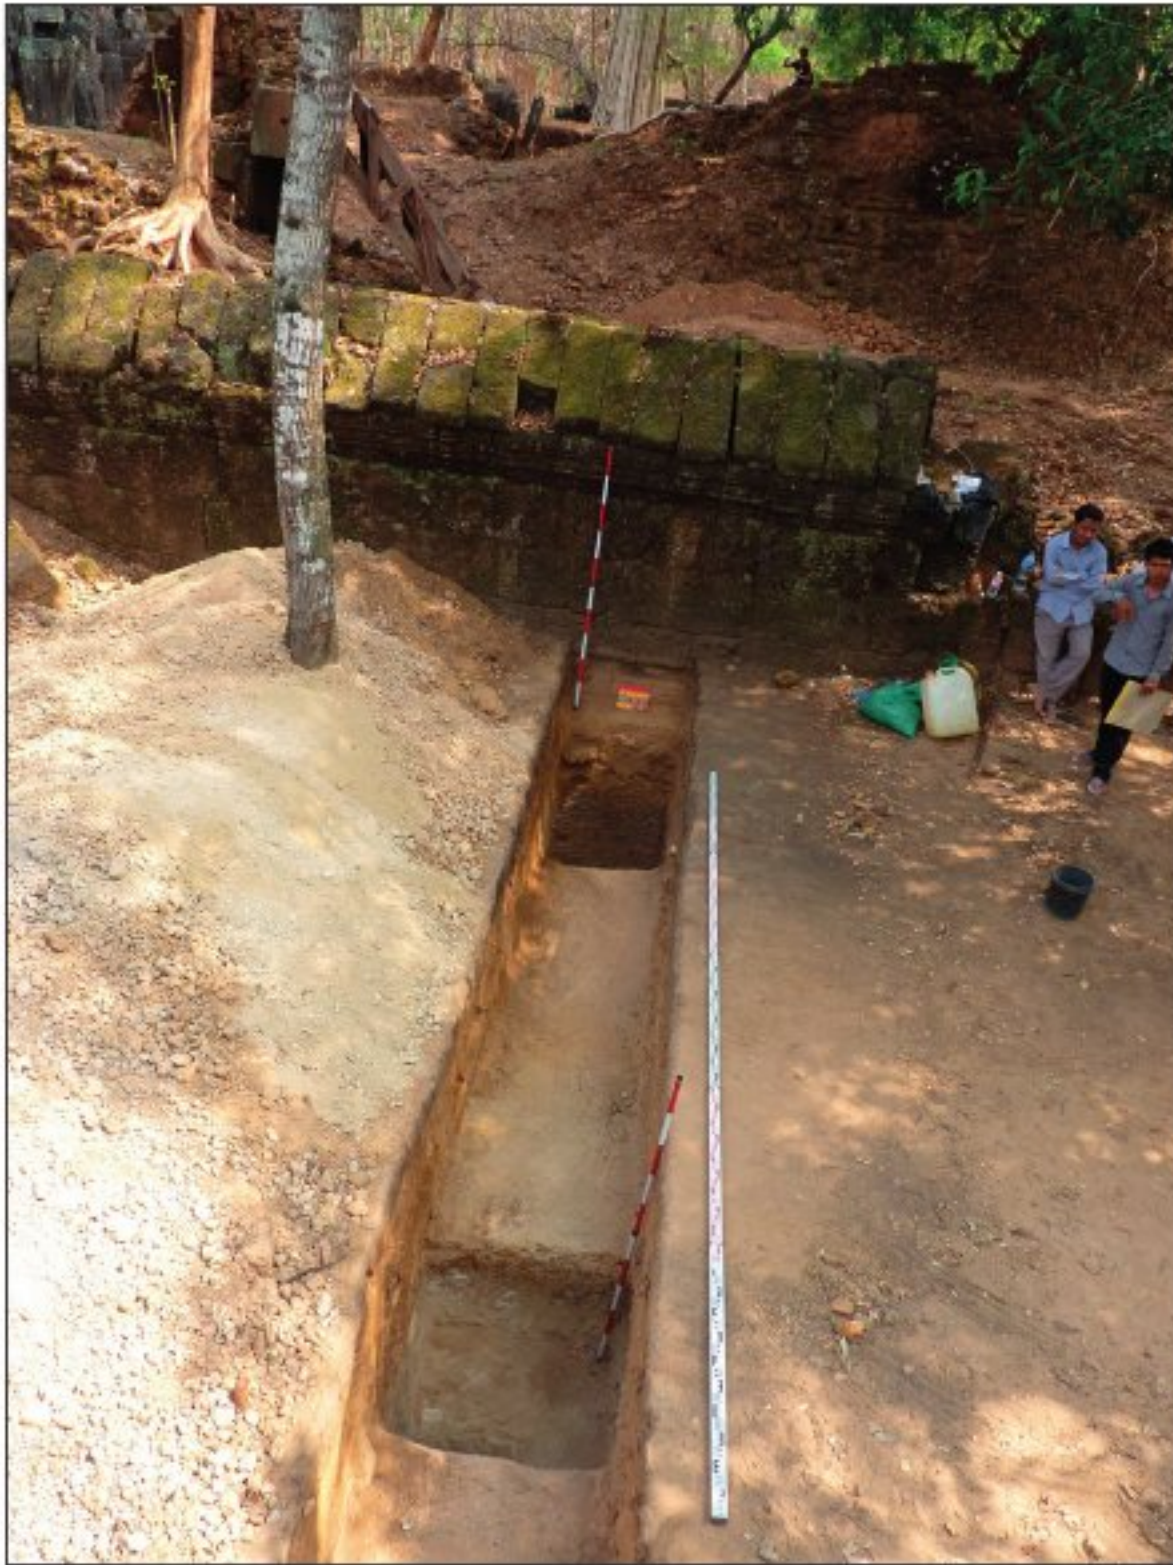
Figure 2: Trial Trench 15 from the north

The trench at Trial Trench 15 was begun in the space between the double perimeter wall built from laterite blocks roughly on the northwest-southeast central axis of the complex (Section BC93, figures 2 and 3).

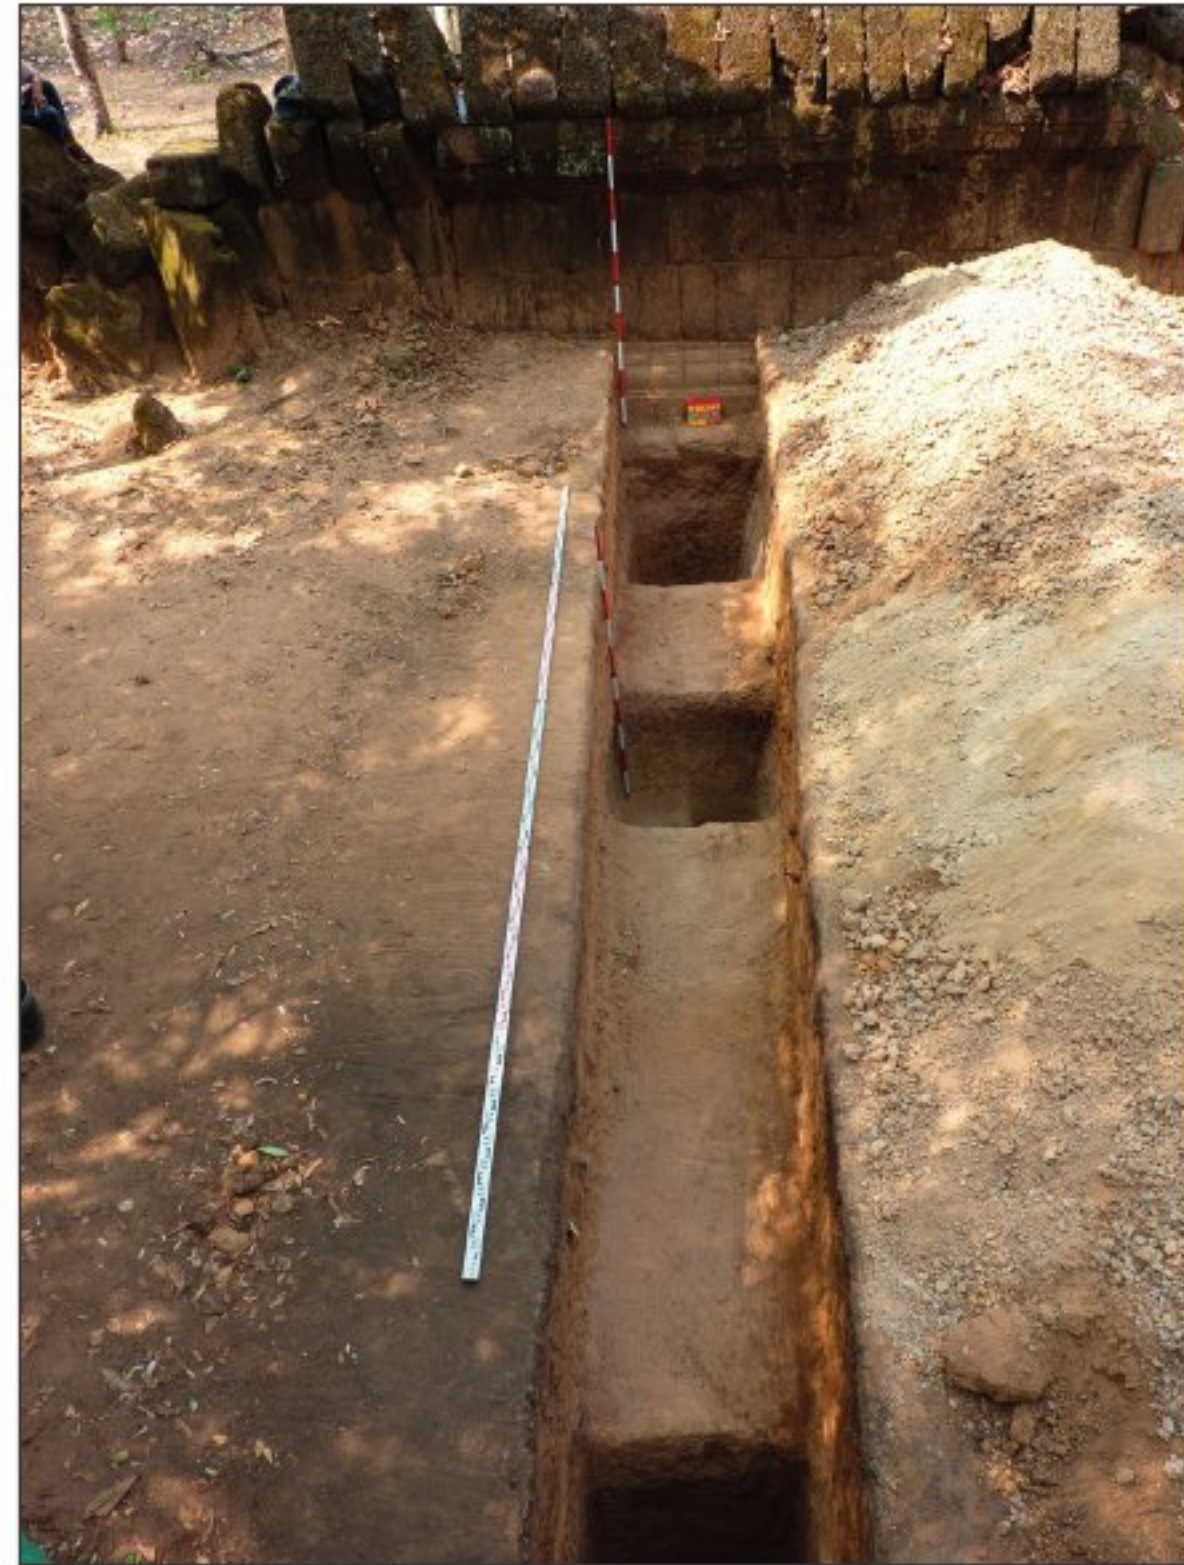
Figure 3: Trial Trench 15 from the south

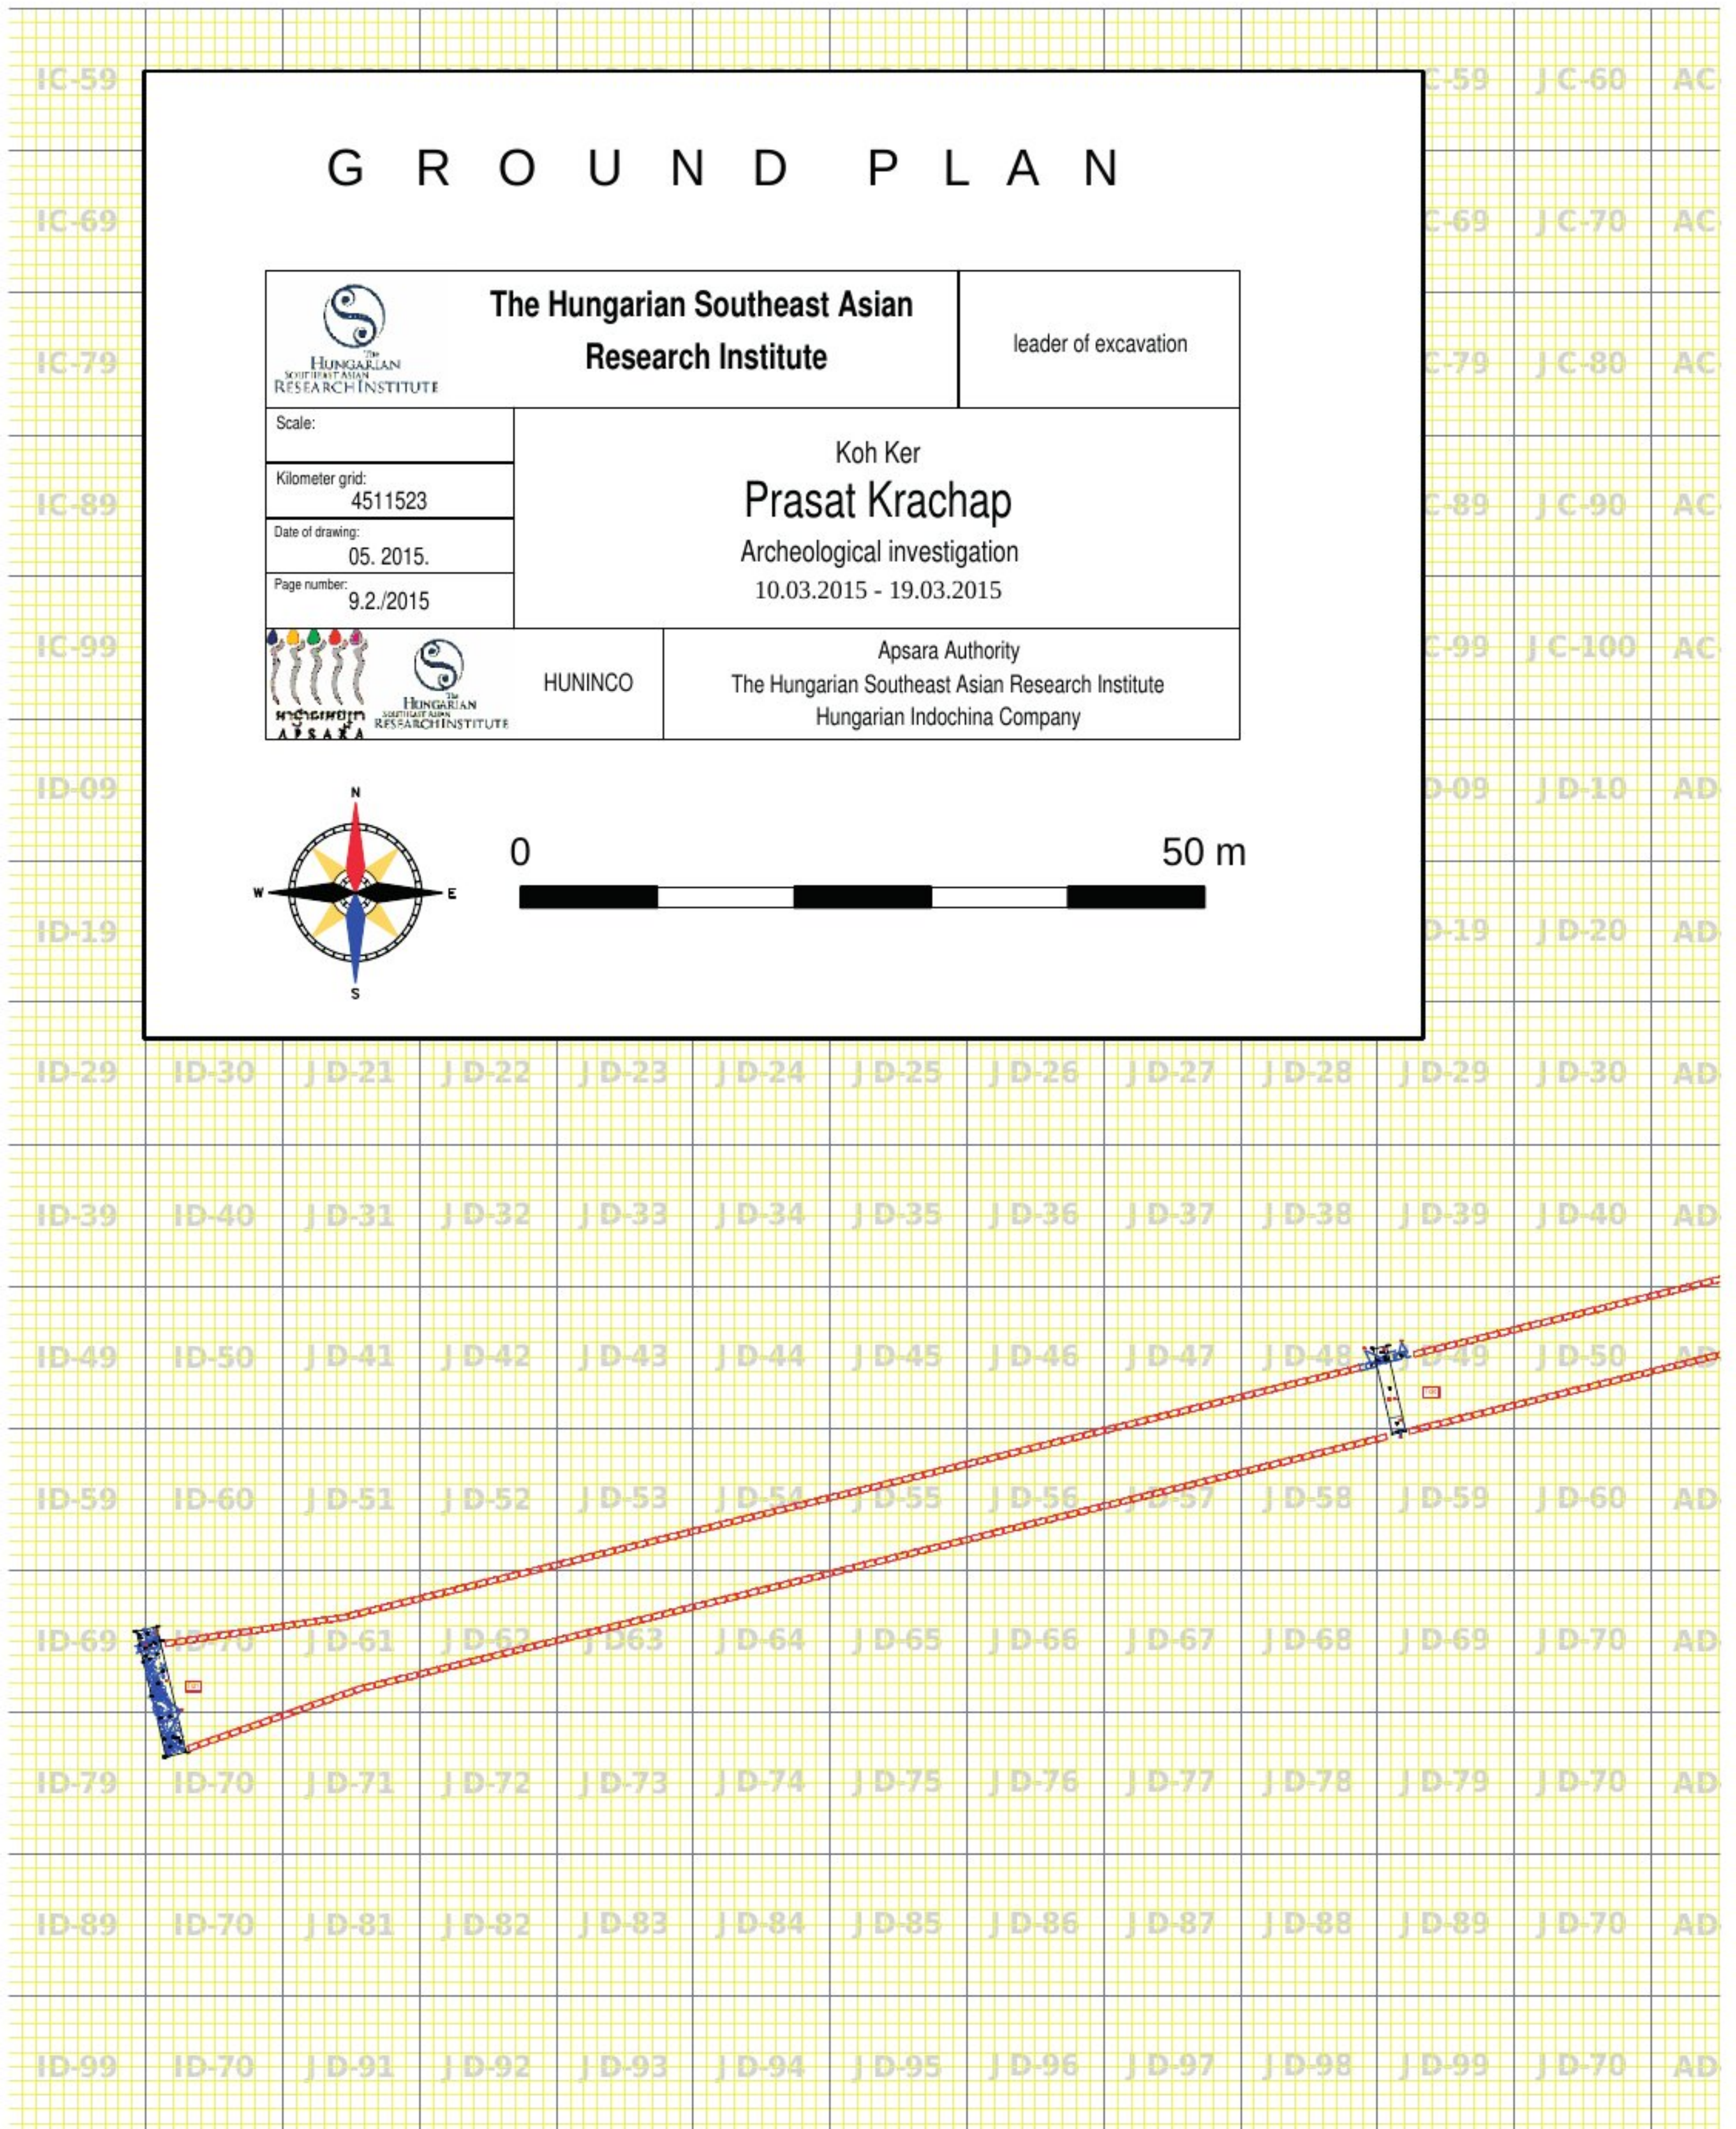
Figure 1: Summary layout plan, Prasat Krachap 2014-2015

After the completion of the systematic site survey and trial excavations (BELÉNYESY 2013) begun in 2011, and the KALC-LiDAR programme,¹ we then continued archaeological exploration in the area on the basis of the 5-year cooperation agreement we had concluded with APSARA and the research plan that formed a part of that agreement (Figure 1).

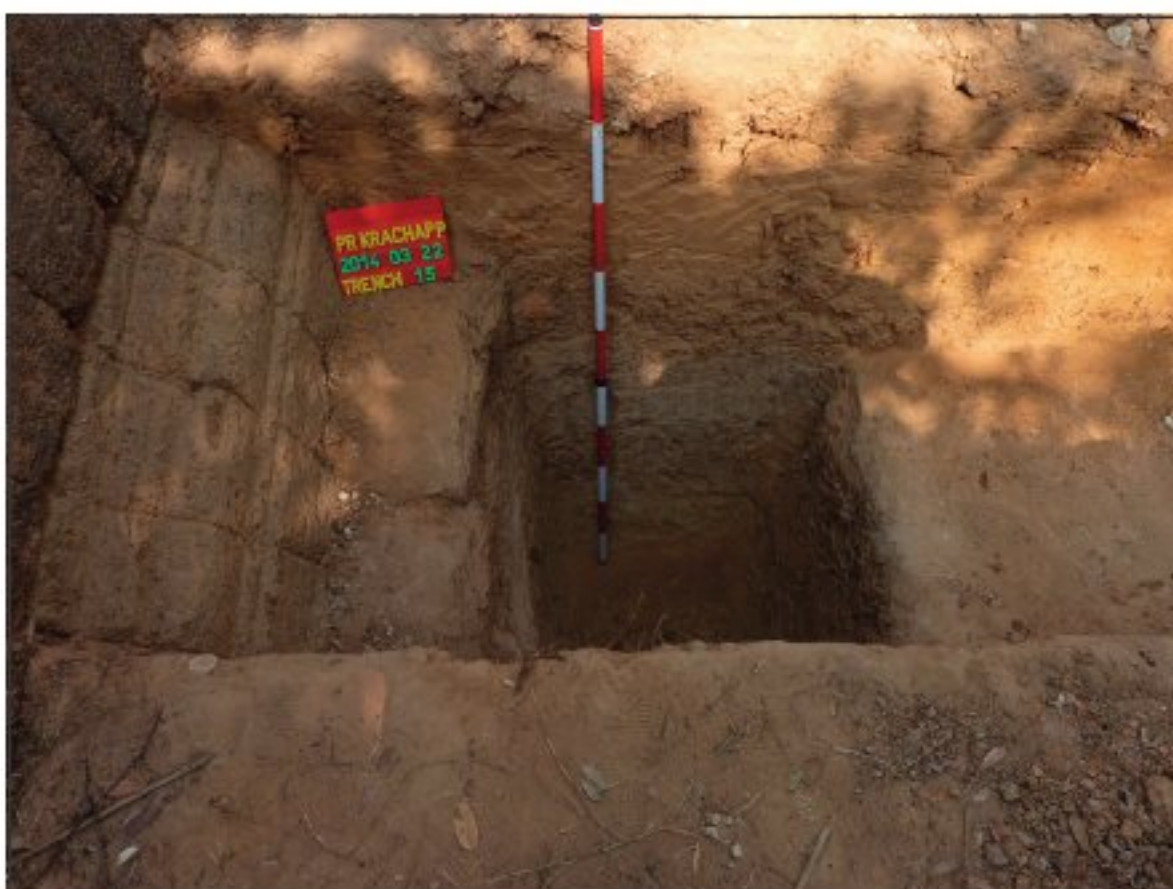
Figure 5: Foundation layers of the external perimeter wall in Trial Trench 15

During the excavation we found that the original ground levels, which matched the profiled pillar footings, were covered by some 40-50cm of material. Beneath that we observed an approximately two metre deep artificial strata of sand, established prior to construction, and a highly compacted layer formed from a mixture of clay and laterite granules (Figure 4). In the area between the walls, some 2.5 metres from the external perimeter wall—similarly to Trial Trench 9 to the front of the south facade of the western range of galleries—we once again identified the remains of a wall structure built from small laterite blocks running parallel to the connecting walls (Figure 5).

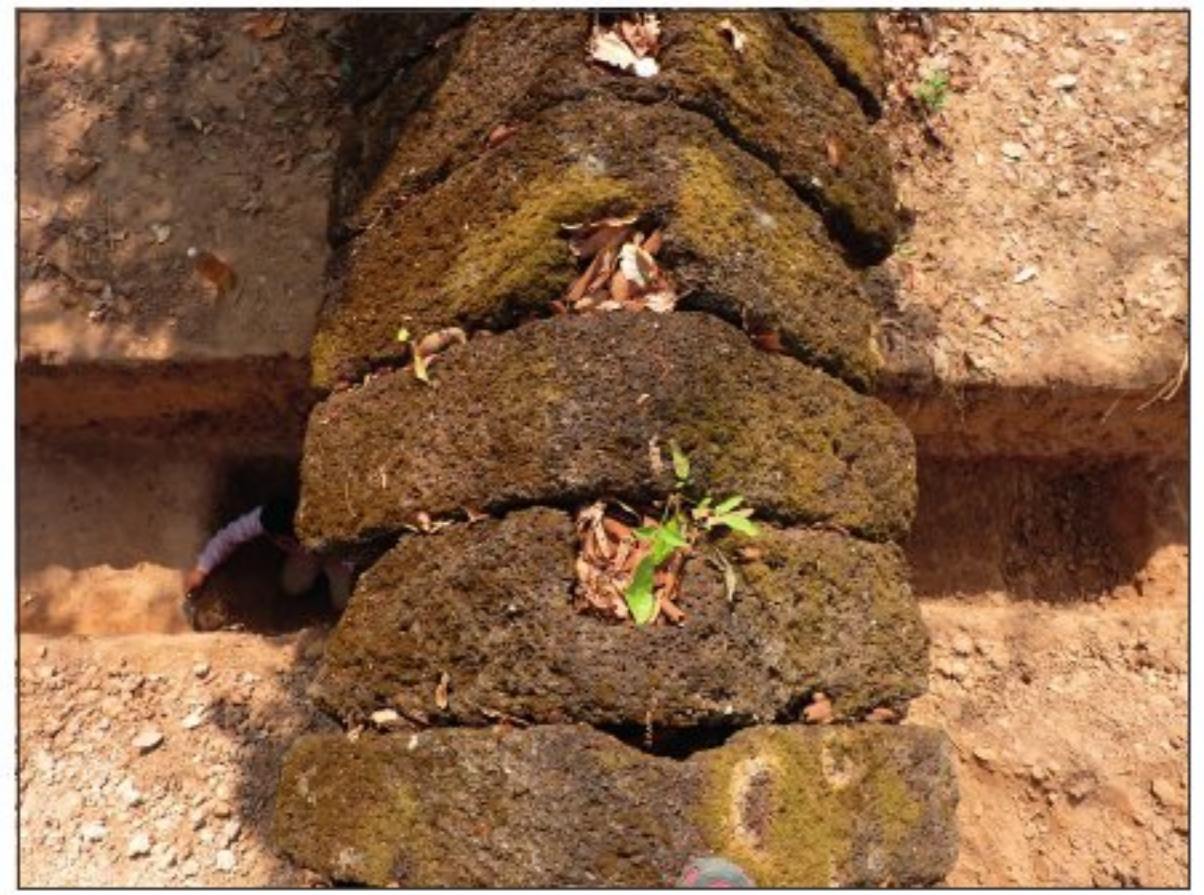
Figure 6: Trial trenches 15 and 17 photographed from the top of the external perimeter wall

In trench 17, which followed the line of trench 15 (Section BC92, figures 6 and 7) on the far side of the wall, we were also able to identify the construction layers that

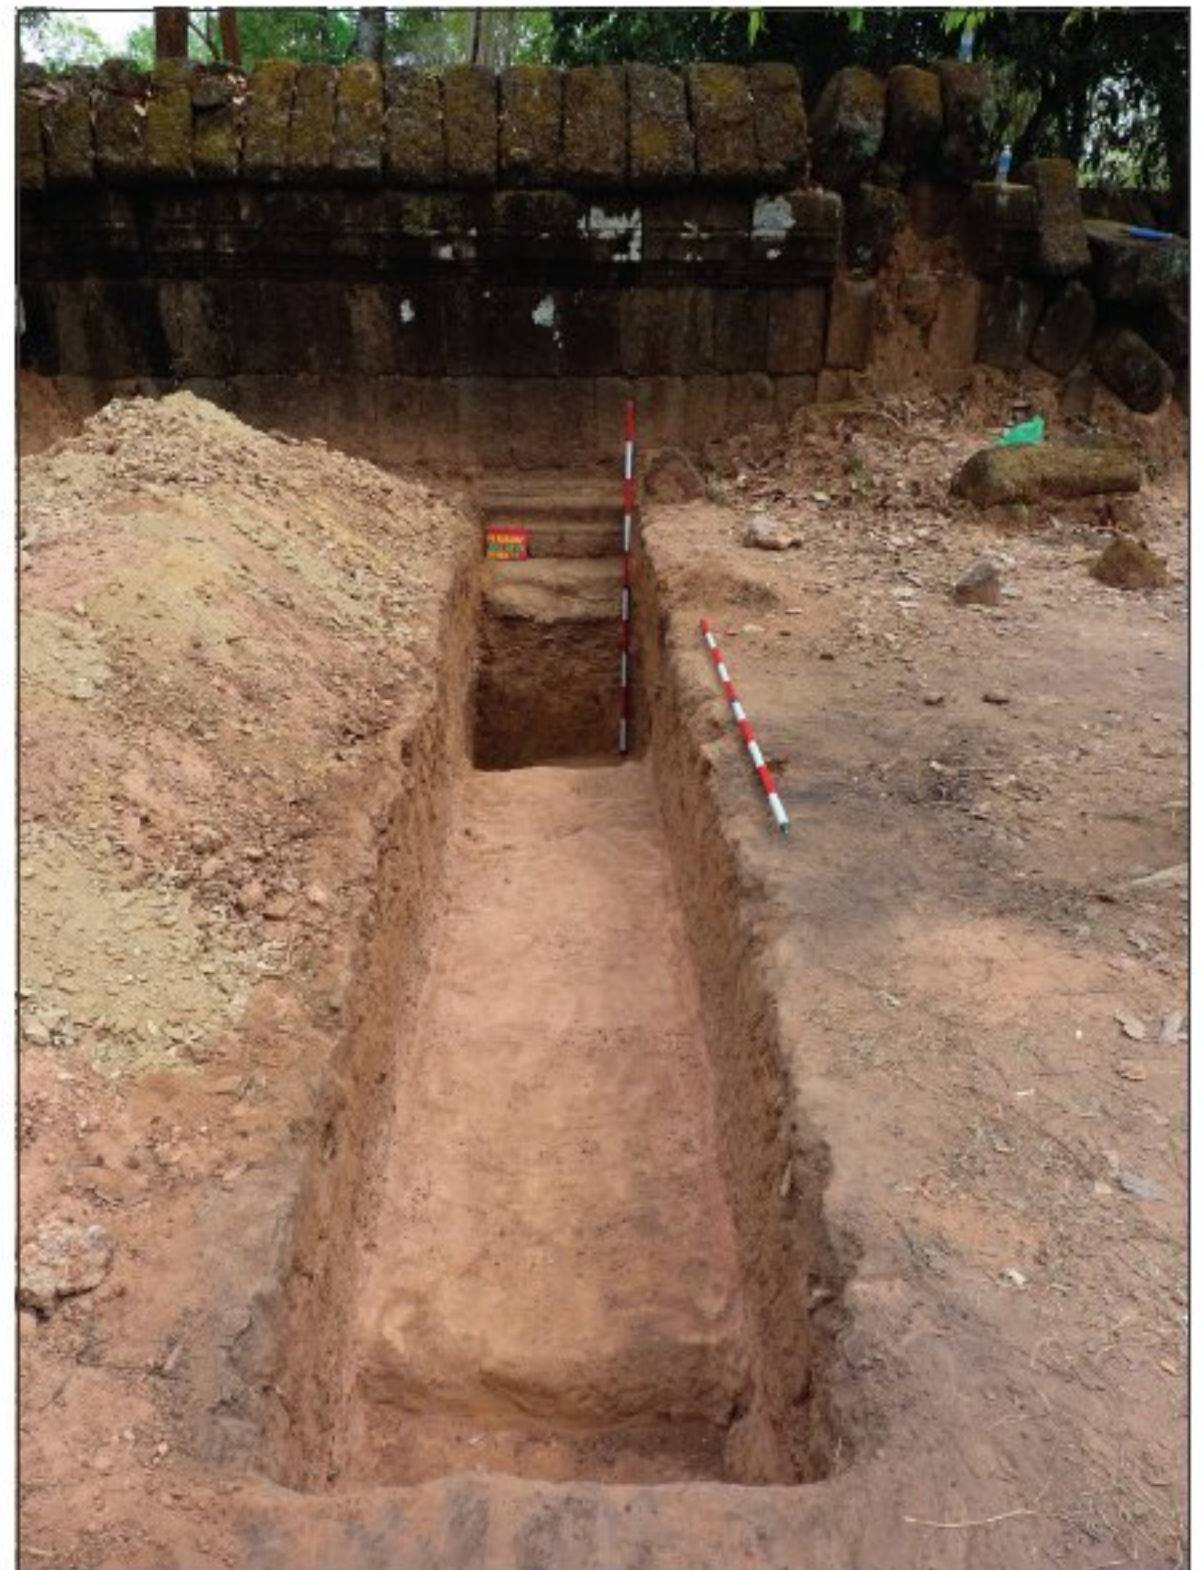
Figure 7: Trial Trench 17 from the north

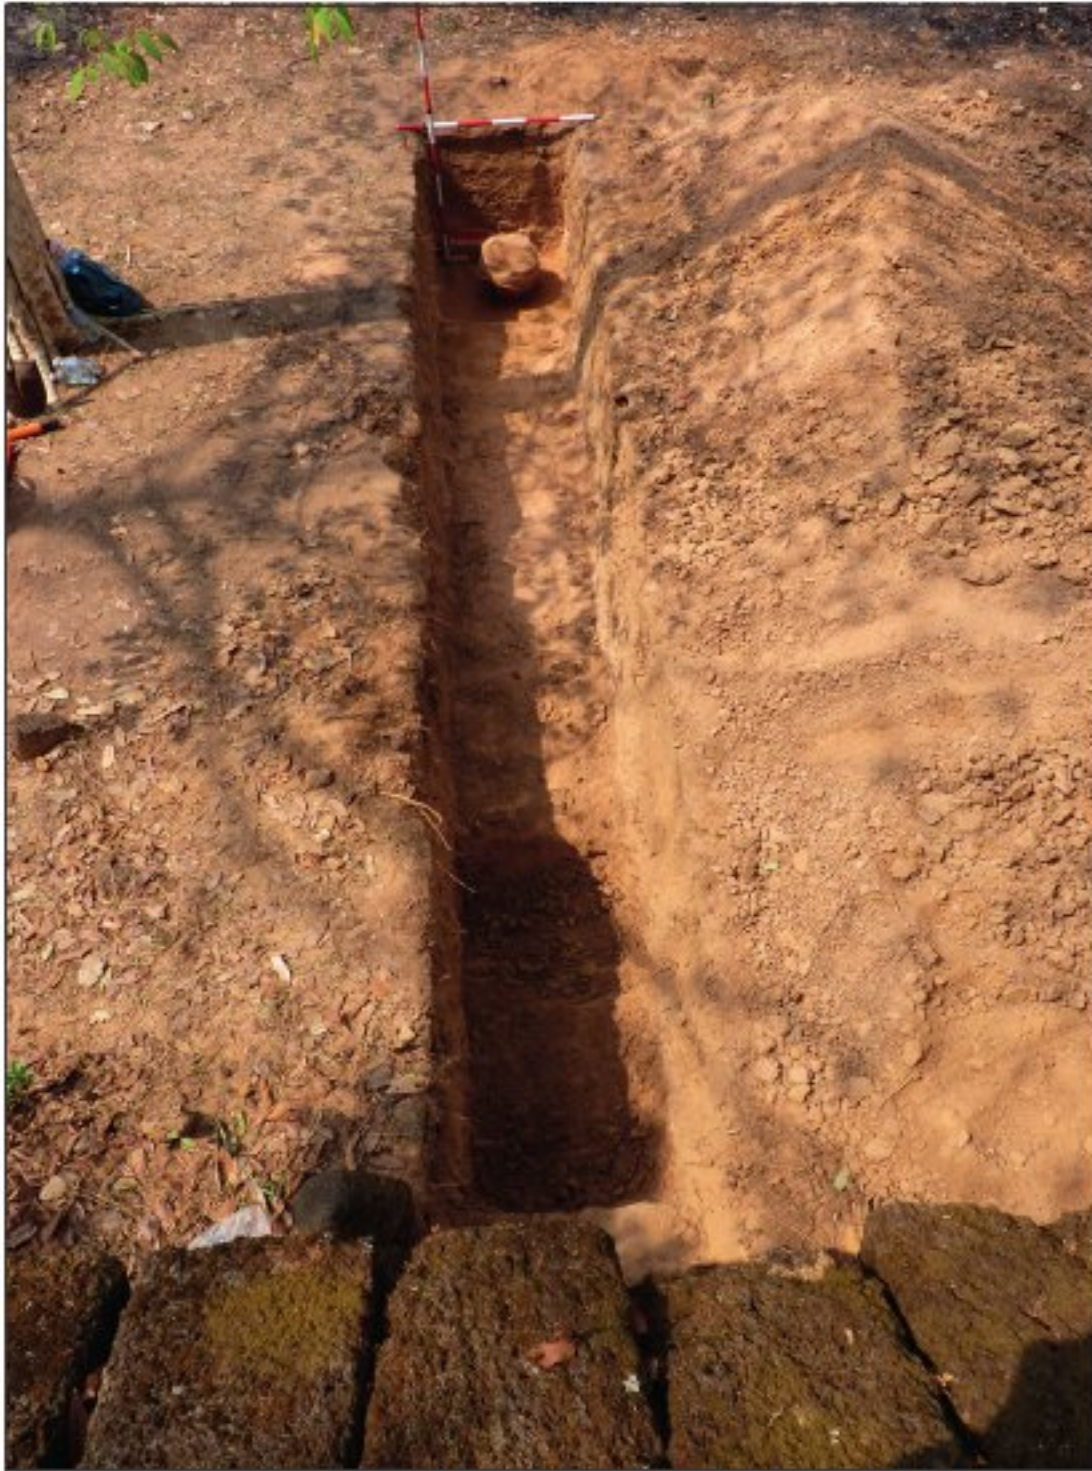
Figure 9: Complete vessel found in the north end of Trial Trench 17

essentially corresponded to those excavated on the inside (Figure 8). Household ceramics were found in large quantities among the material covering the original ground level, as well as the strata below it, which indicates a settlement in the area. At the end of the trench, almost 6 metres from the external perimeter wall, we were lucky to find a complete vessel (figures 9 and 10). The soil pressure had impacted on it, which had cracked it, so we were unable to remove it in one piece. What makes it special is that we actually found it in situ at the boundary between the highly compacted clay-bearing stratum that was made prior to construction and the laterite granule stratum that joins the pillar footings. So it is presumably the same age as the external perimeter wall. In view of the fact that it is a slightly splayed, reddish vessel with a simple rim and a curved bottom made by hand for the storage of liquids, it must date to the period from the 10th to the 12th century.²

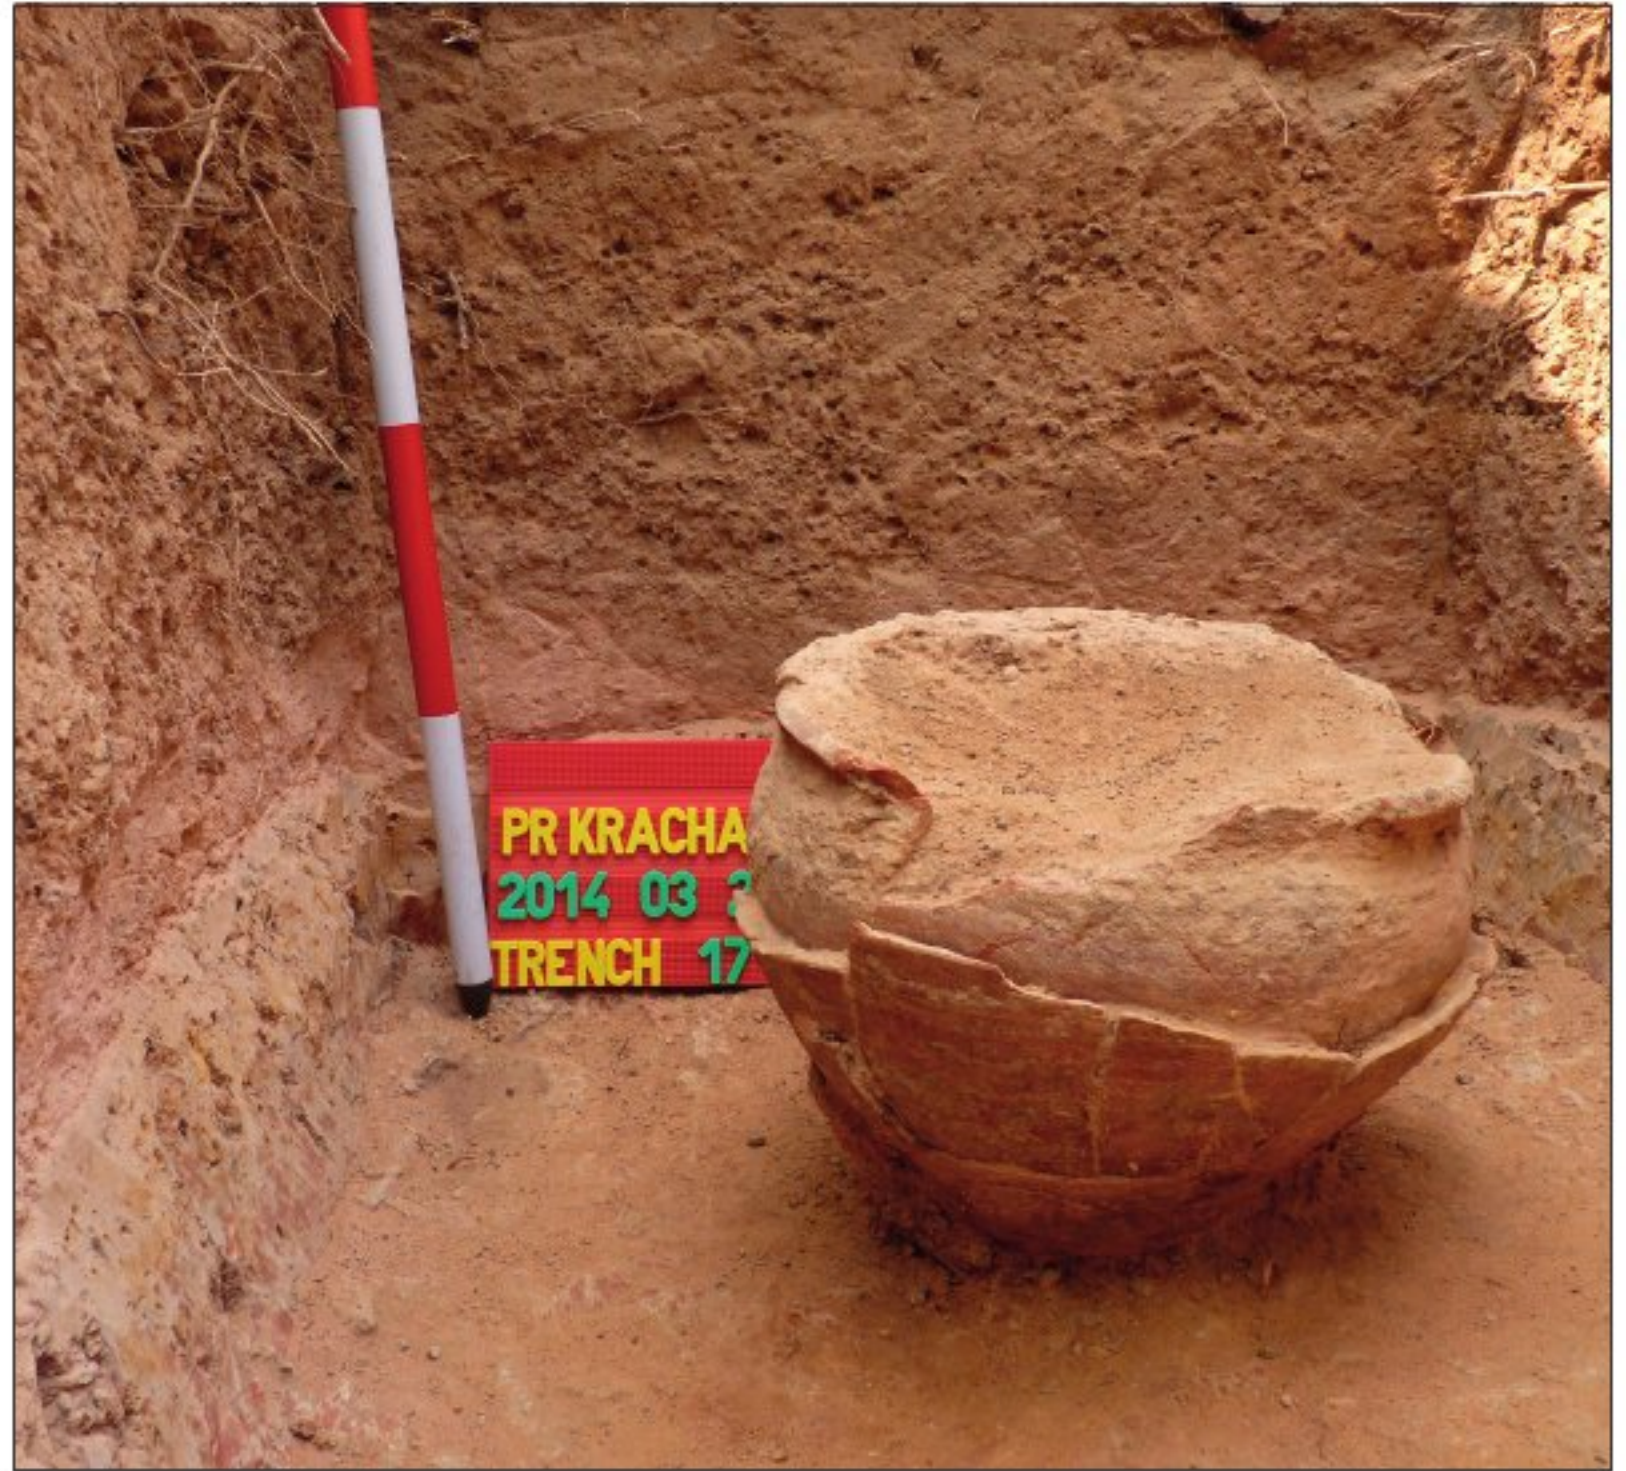
Figure 10: Complete vessel found in the north end of Trial Trench 17

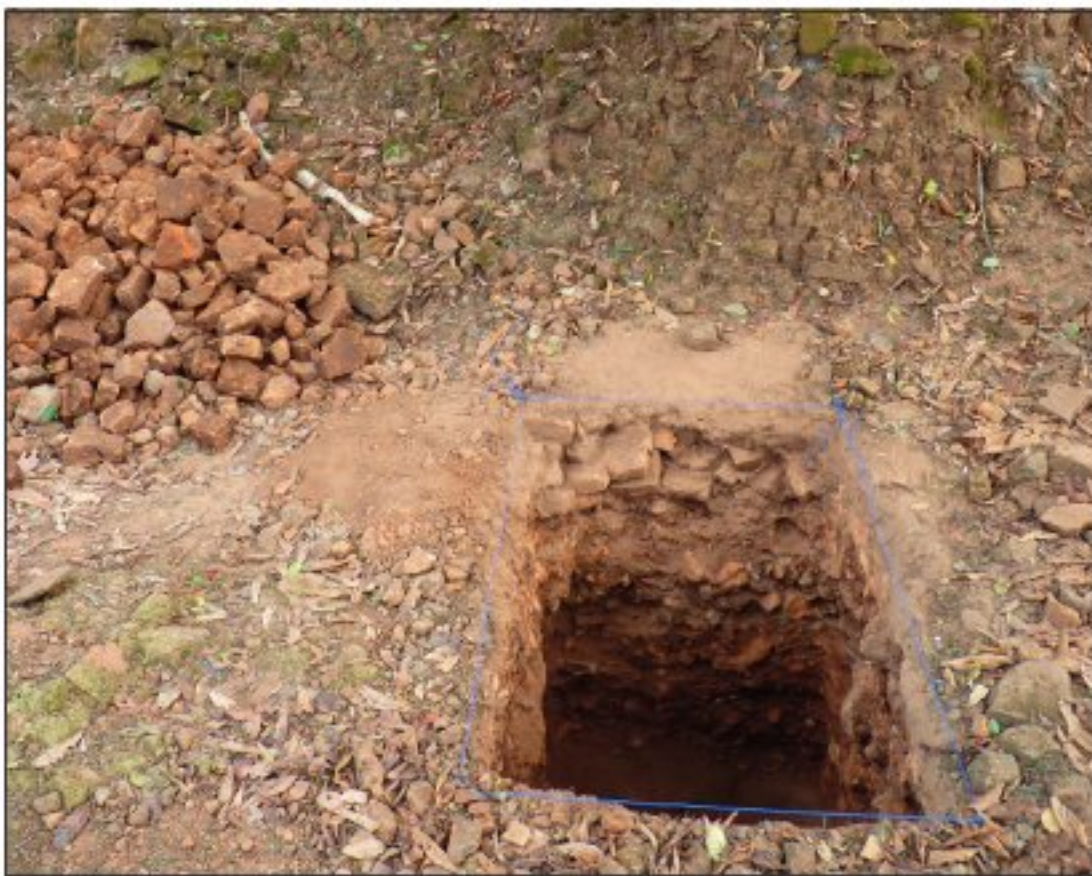
Figure 11: Trial Trench 16 on the north side of the central shrine

As mentioned above, in order to examine the original floor levels and the layer of rubble, we dug a smaller trench inside the area of the shrine, on the northern side of the brick central shrine (figures 11 and 12).

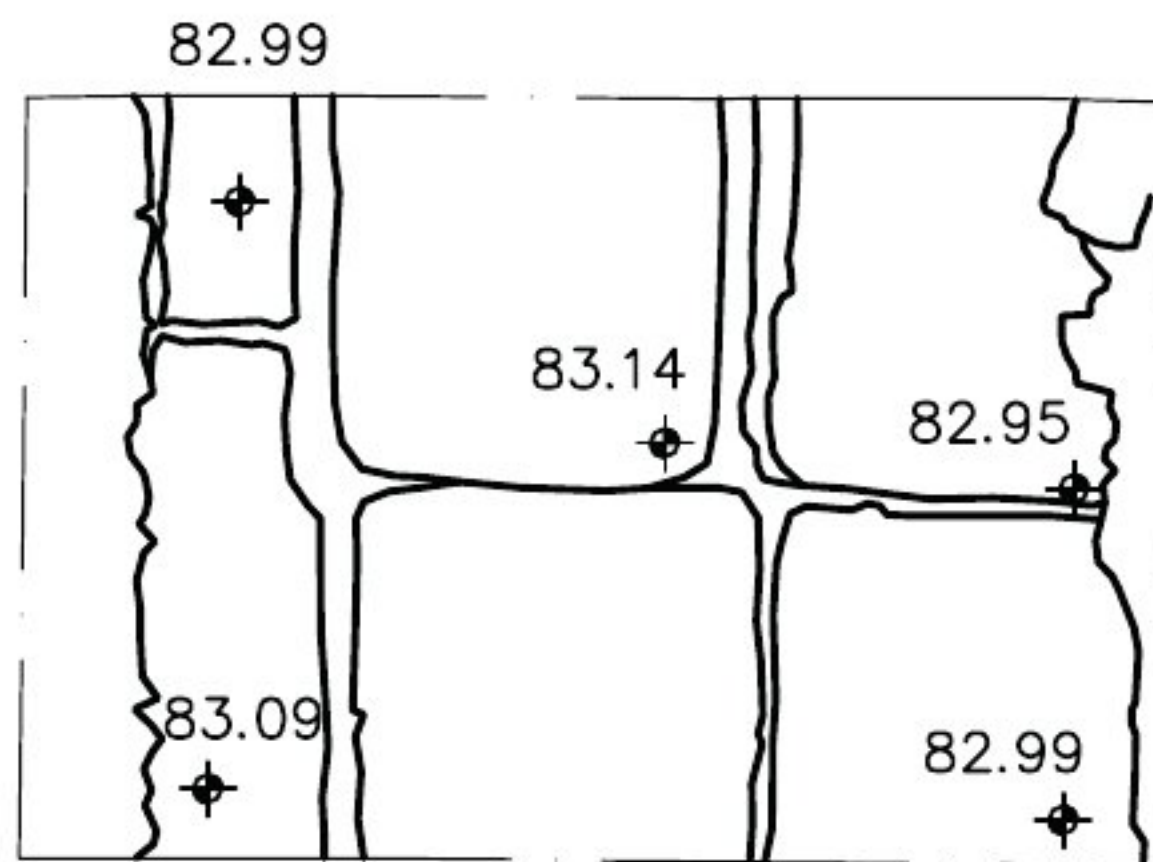
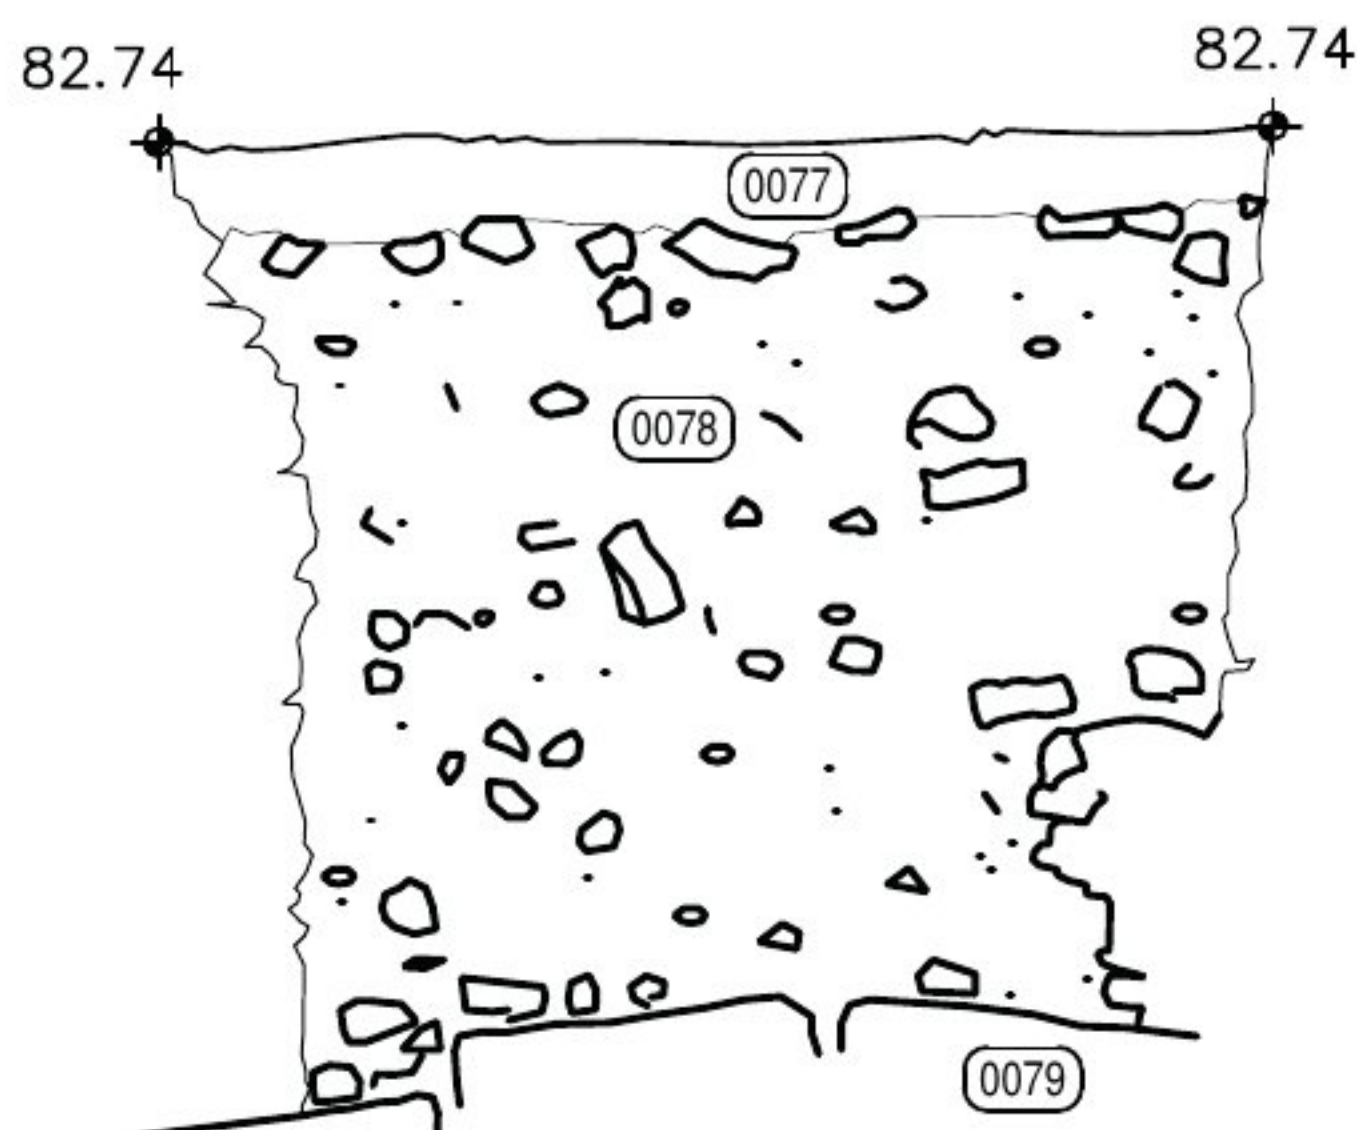
Figure 12: Top-down and cross-section drawing of Trial Trench 16

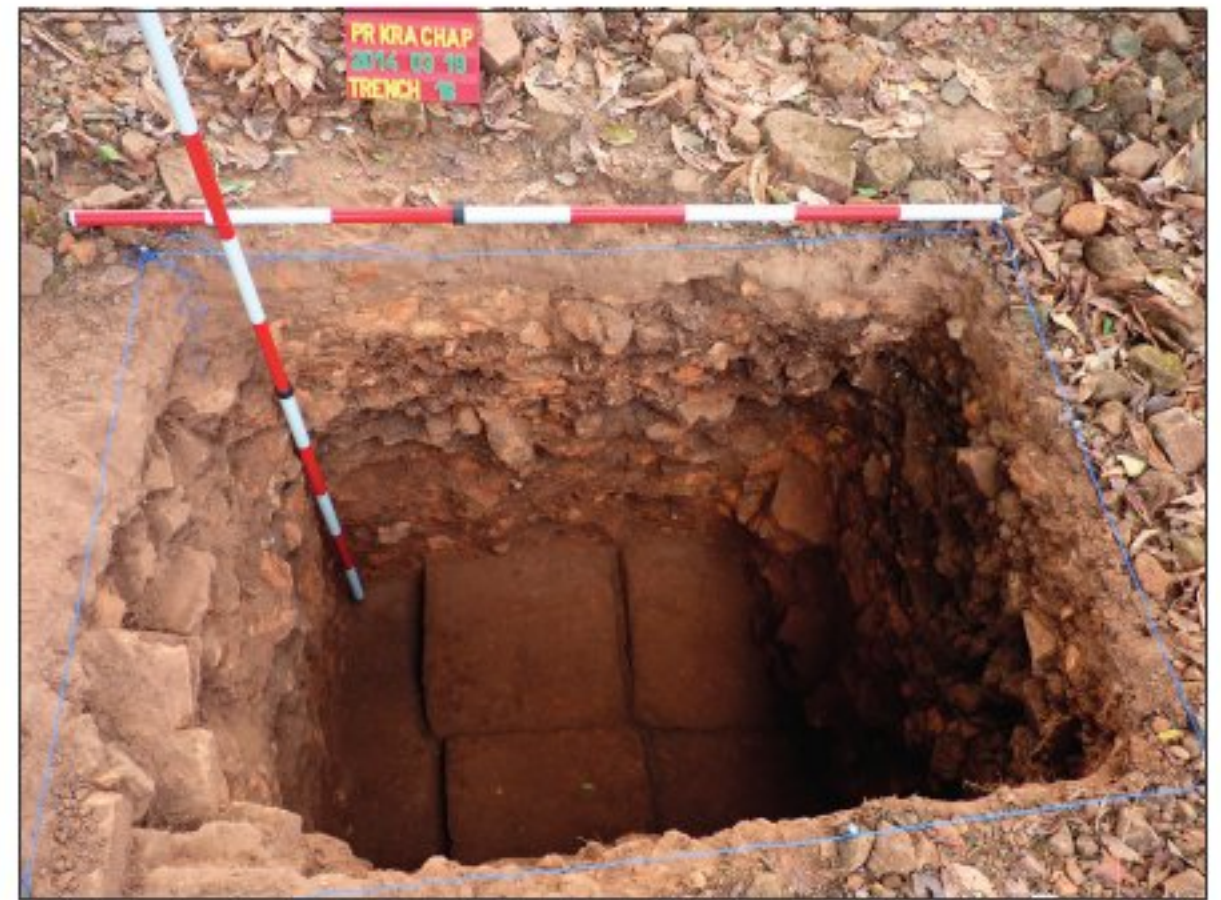
Figure 13: Floor level with sandstone slab paving

identified the original floor built from sandstone slabs (figures 13 and 14). The absolute level of the floor, comprising of 50x50 cm carved slabs, corresponded with that of the footings found at the perimeter walls. The rubble only yielded a side fragment from a brown glazed vessel and a piece from the rim of a red, unglazed one. The information gained by identifying the original floor level is very important.

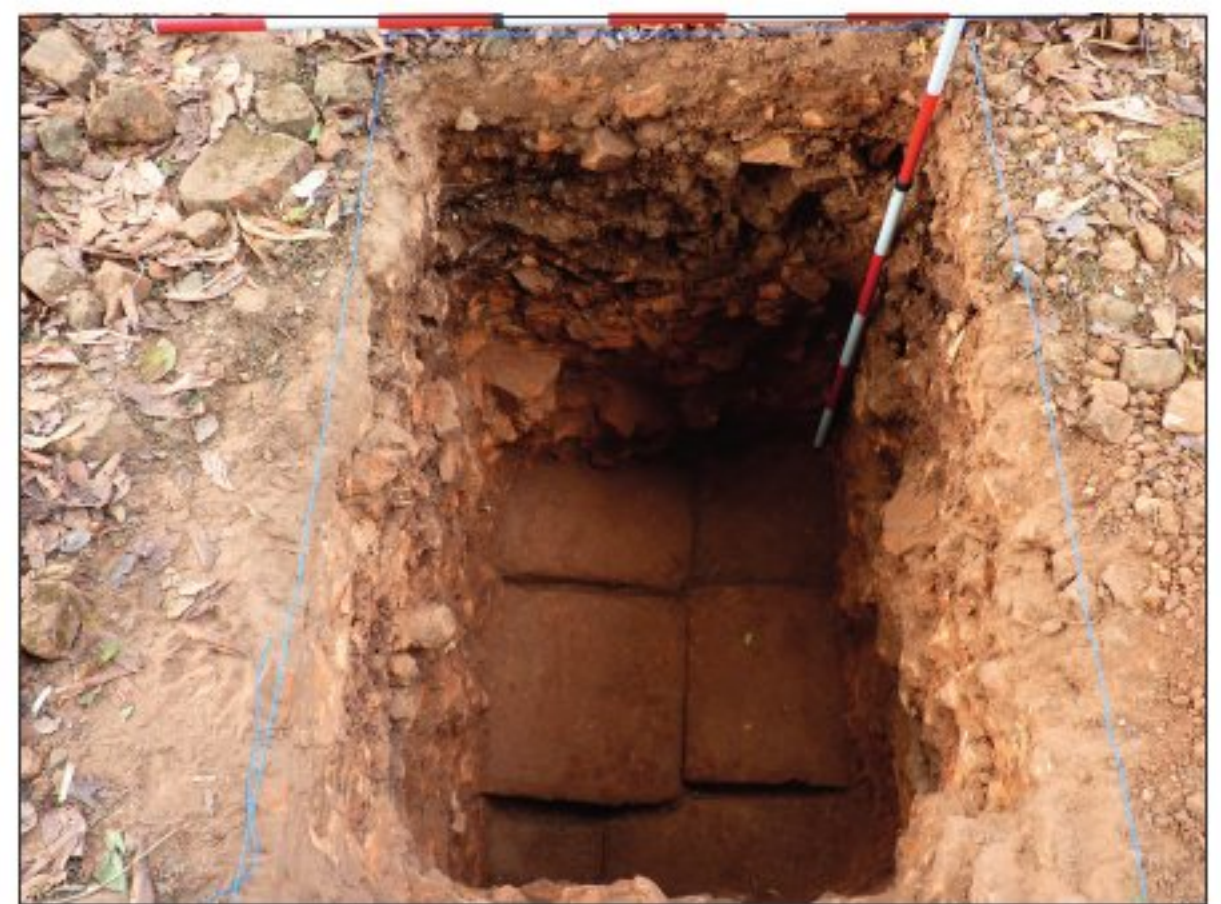
Figure 14: Floor level with sandstone slab paving
