KÁROLY BELÉNYESY, PhD

ARCHAEOLOGICAL EXPLORATION IN KOH KER, PRASAT KRACHAP TEMPLE AND SURROUNDINGS, 2014–2015

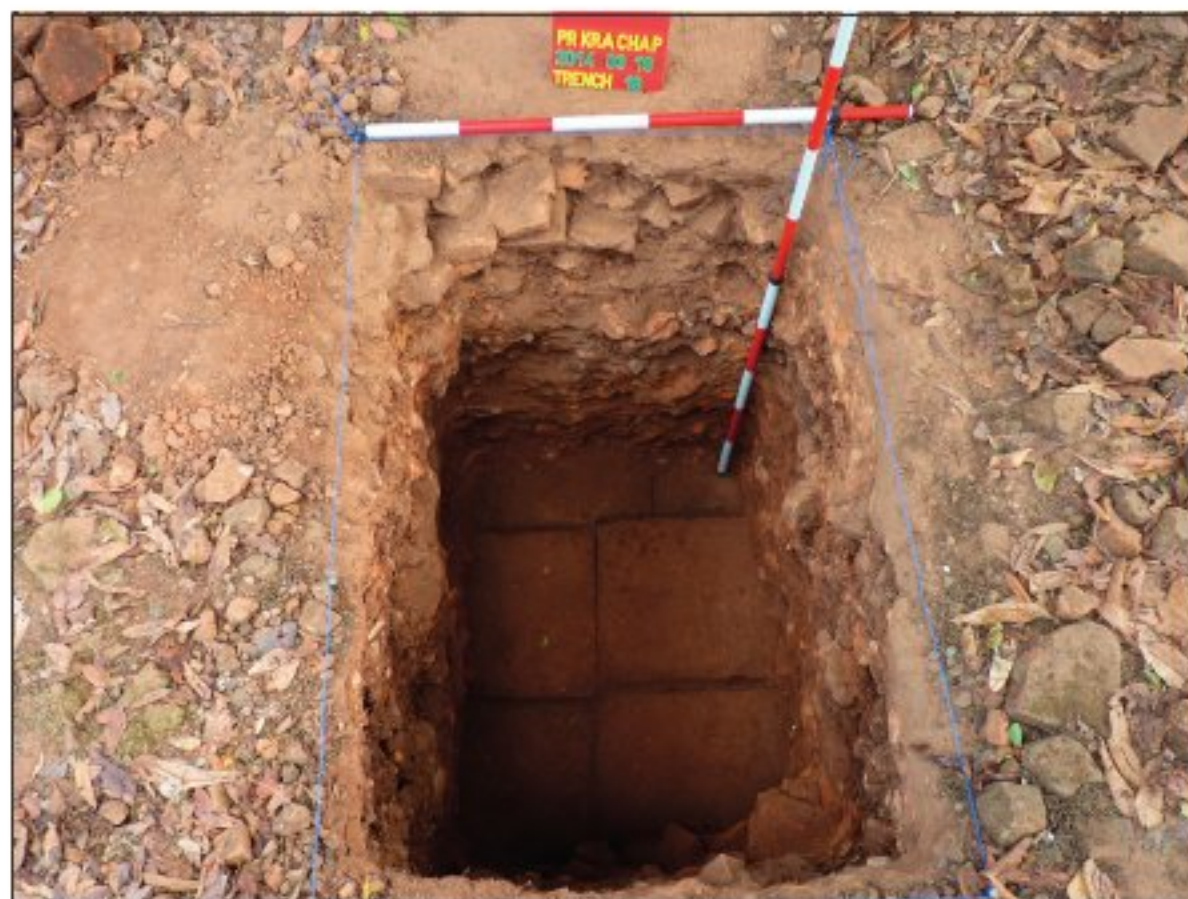
Figure 15: Floor level with sandstone slab paving

The good condition of the sandstone slabs and the over one metre thick layer above them indicates that under the rubble covering the shrine area the original footing levels and floors may have been preserved in rather good condition (Figure 15). Naturally, the thickness of the rubble layer also allows us to determine the volume of soil to be removed and deposited during restoration by modelling the current surface.³

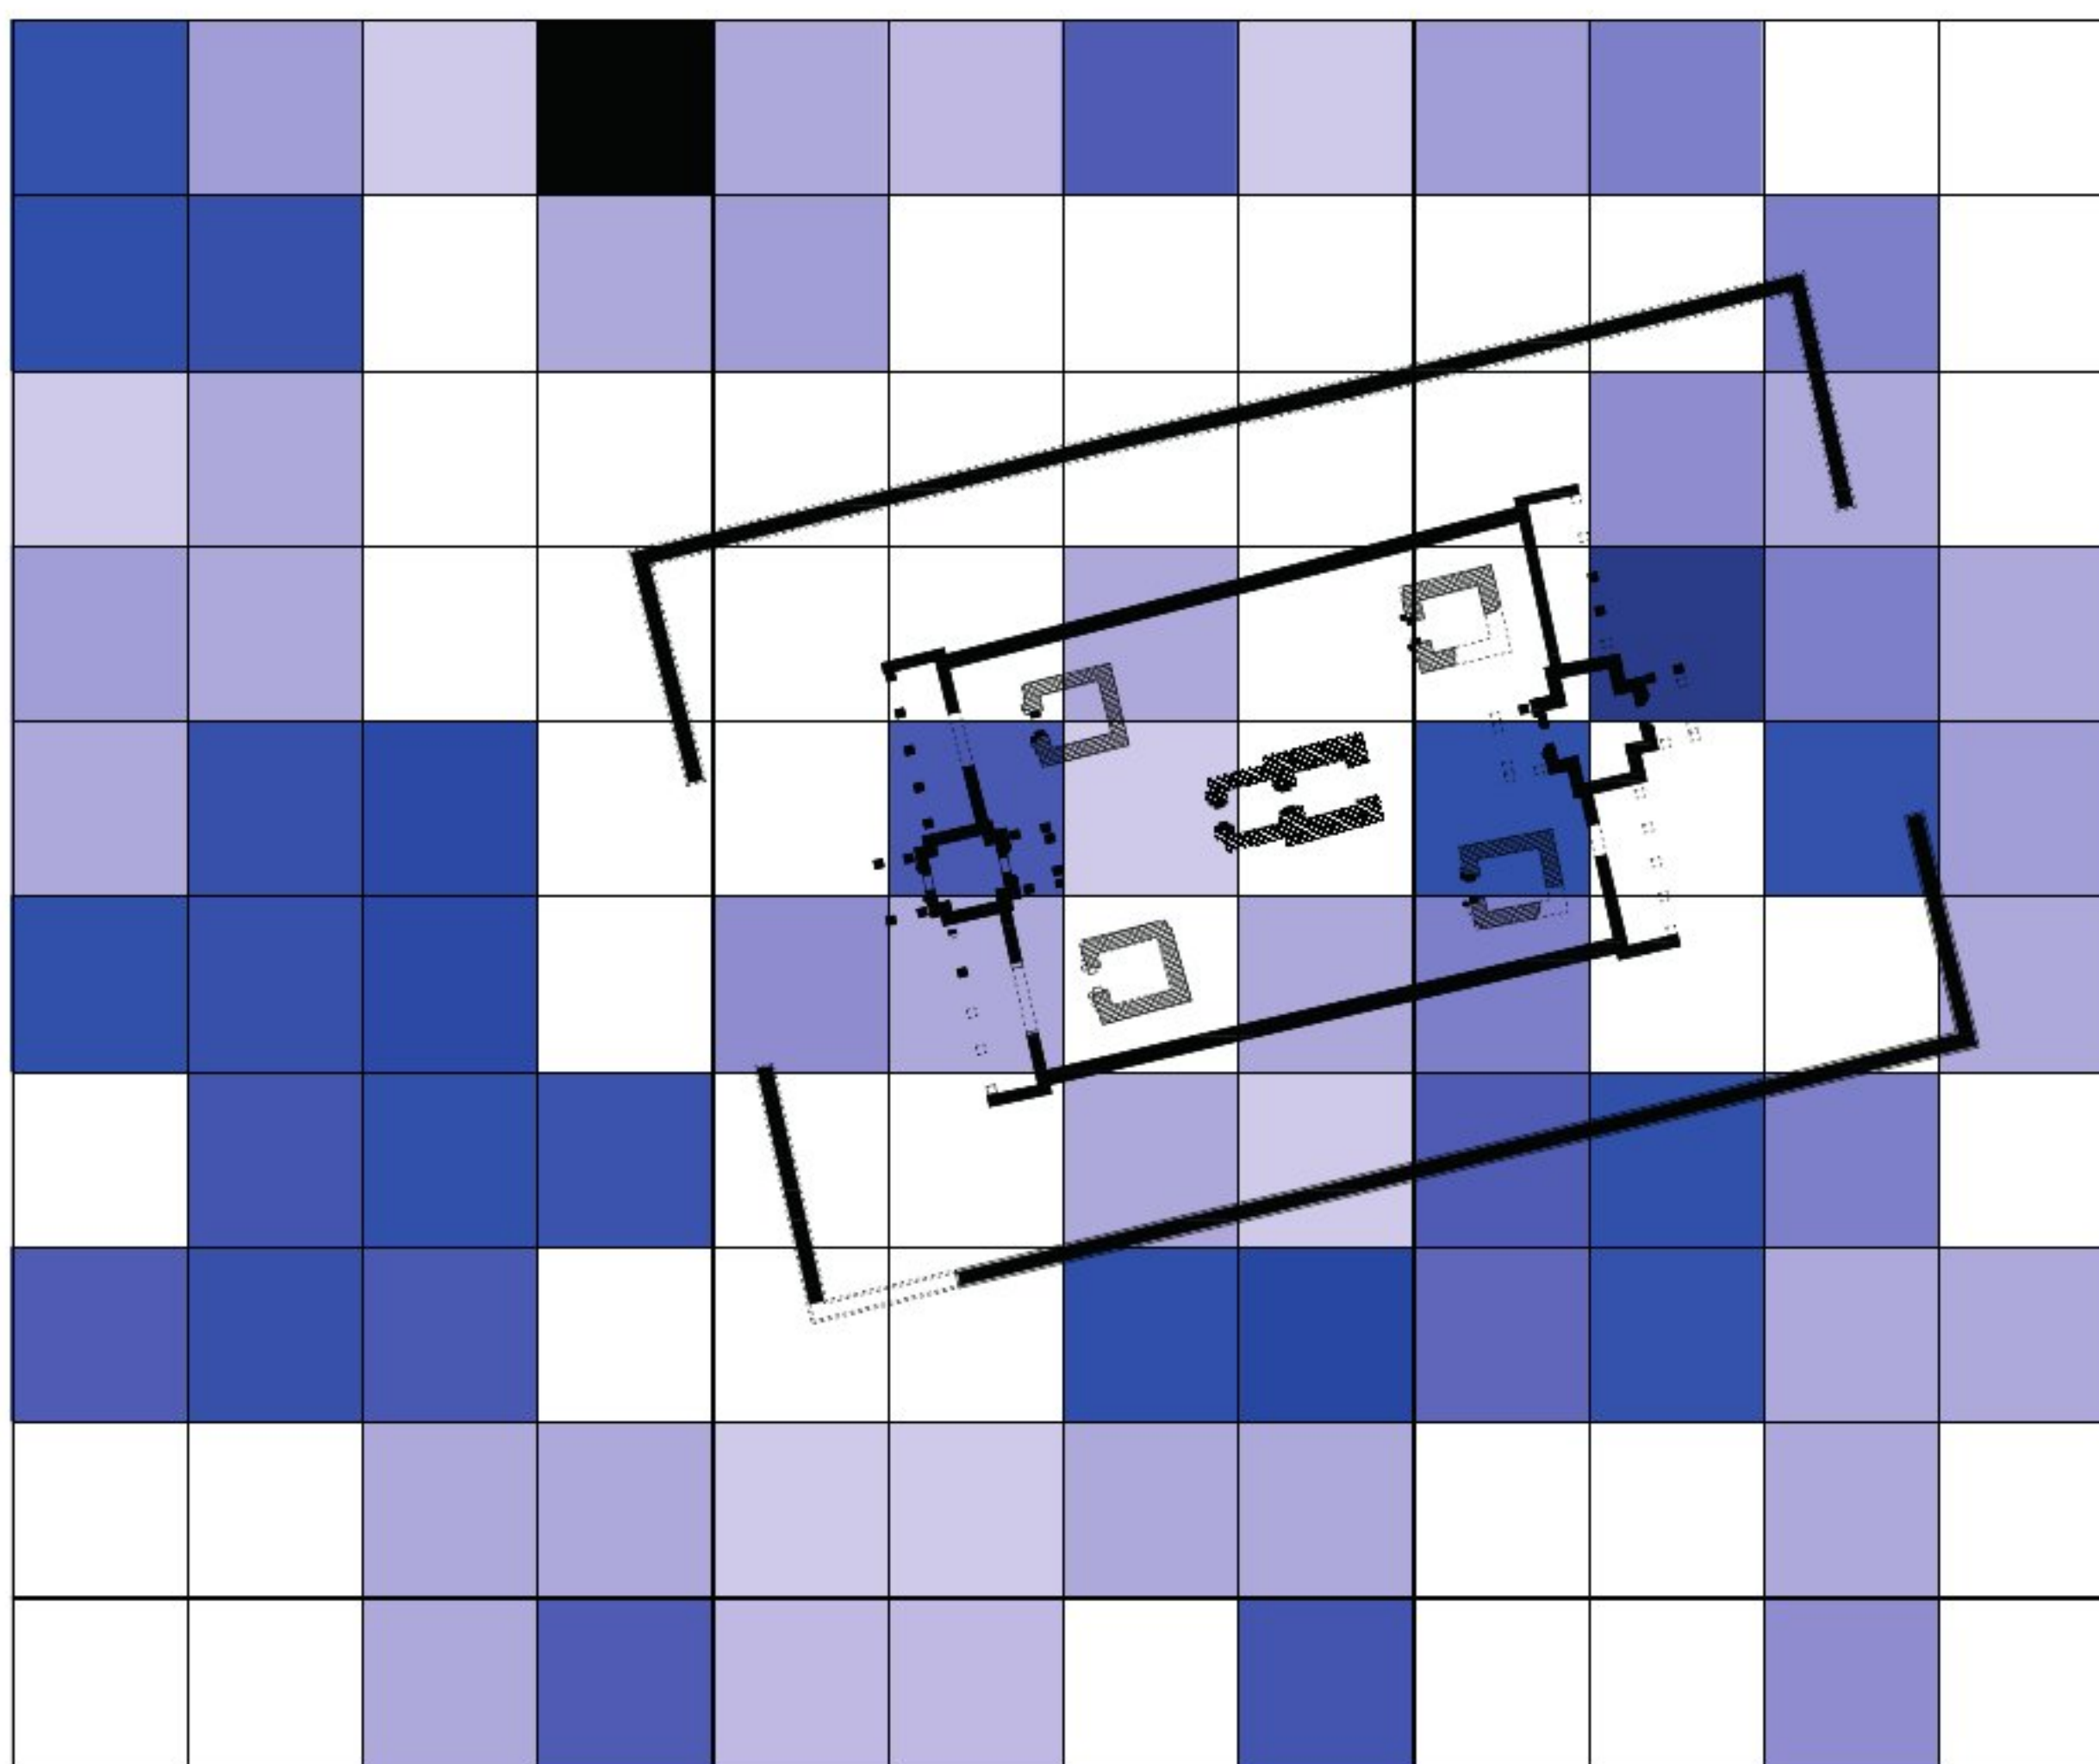
Figure 16: Intensity of surface finds in the environment of Prasat Krachap, based on the data from the fieldwalking survey of 2011, BELÉNYESY 2013, 16, Fig. 7.

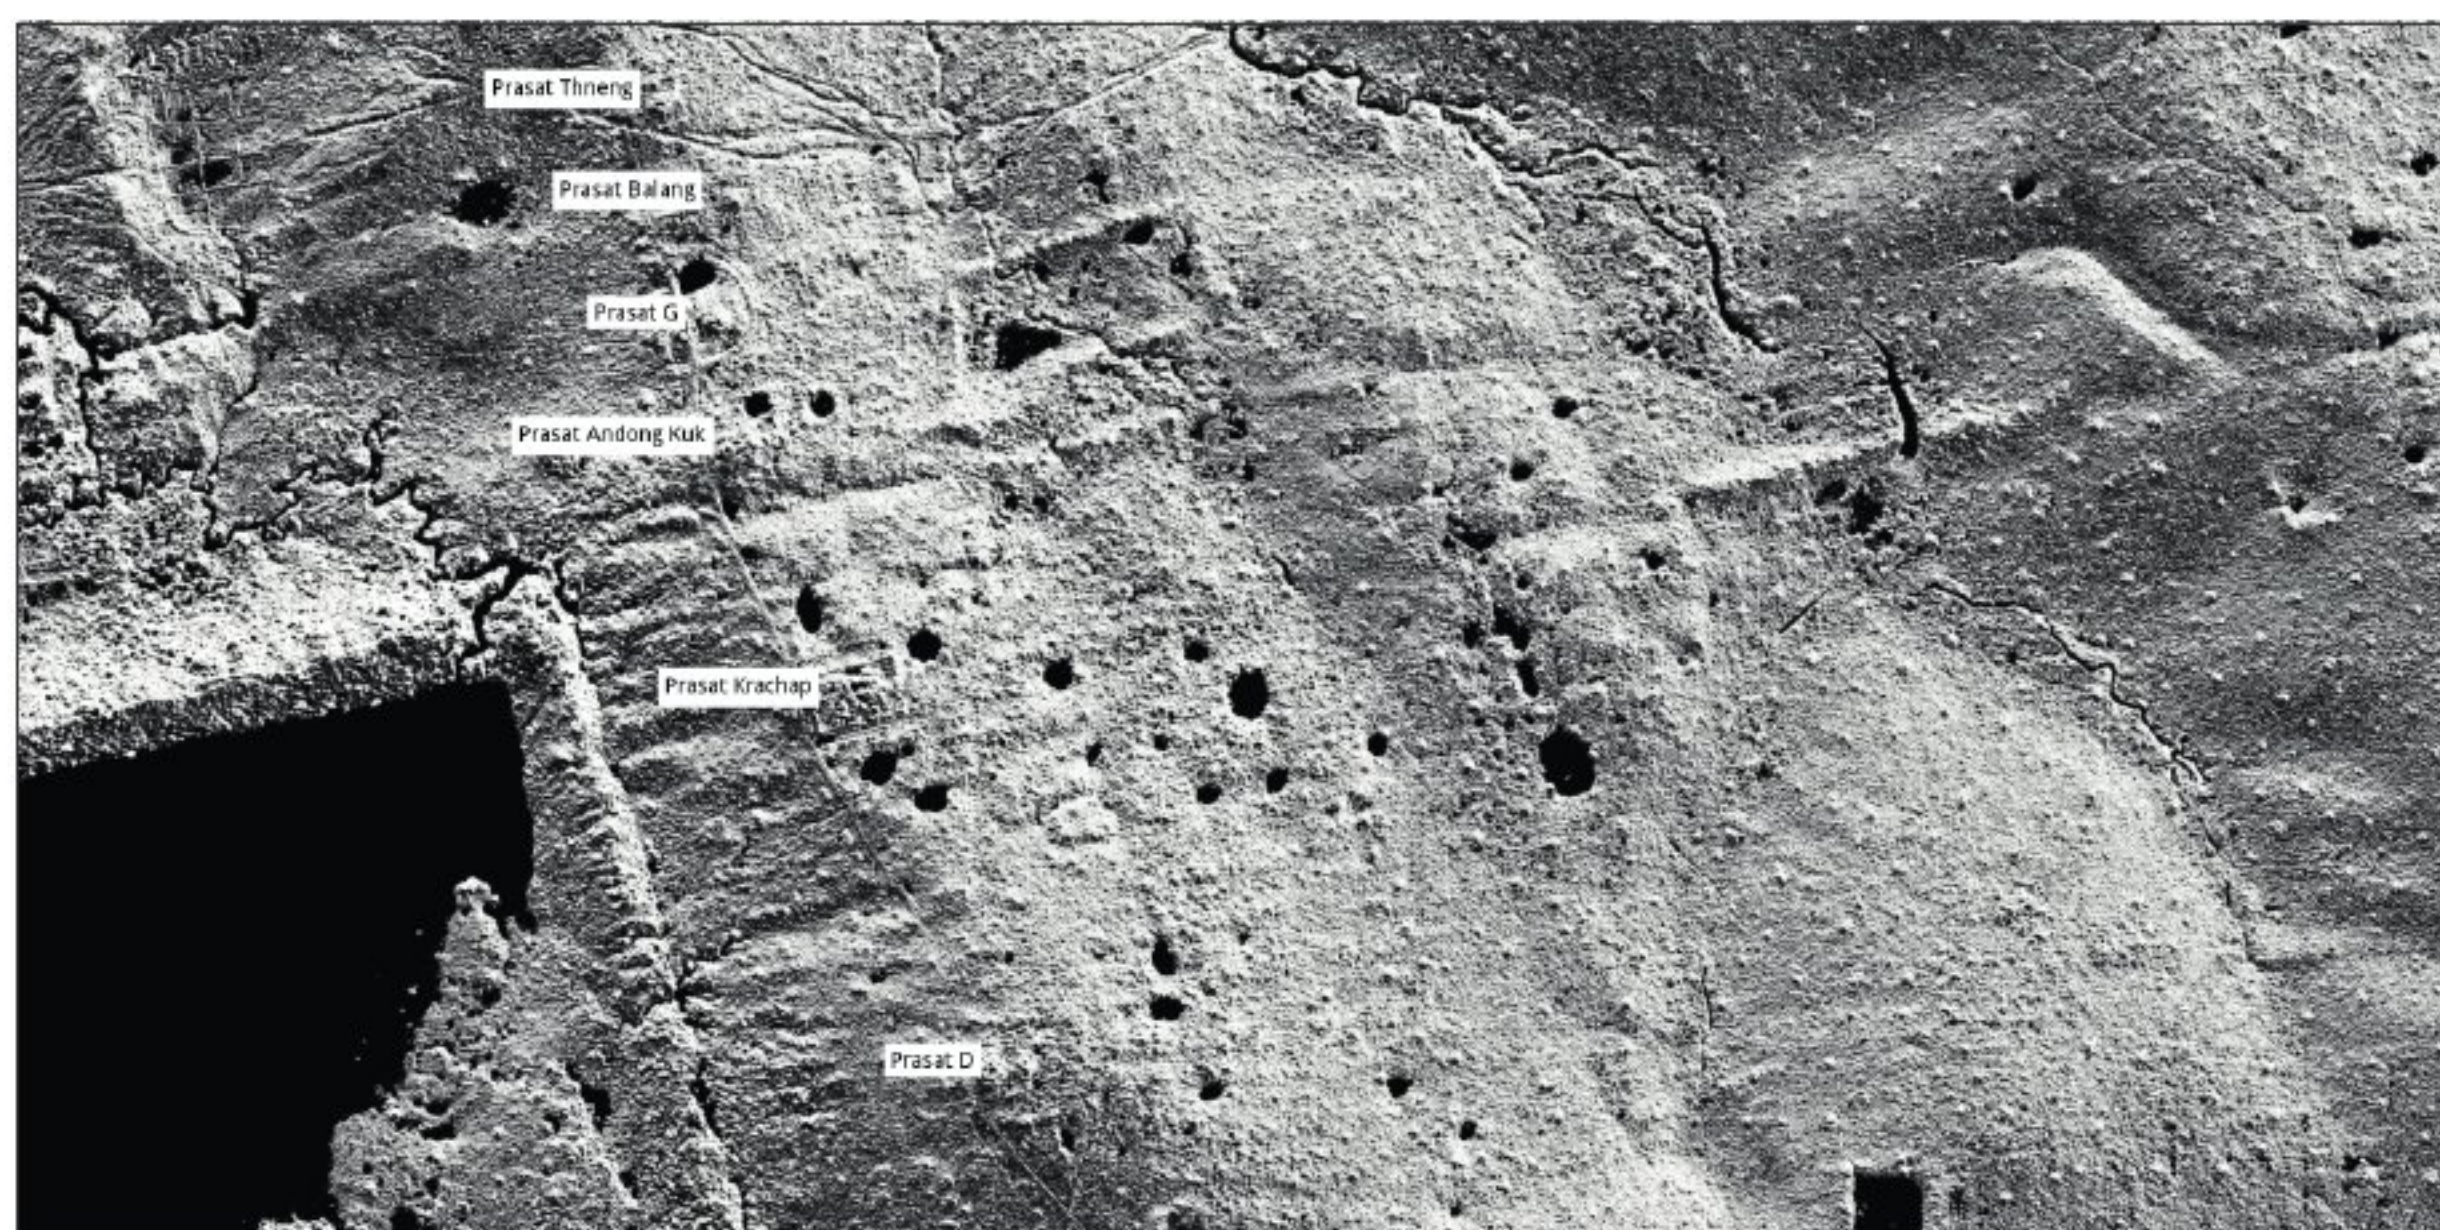
Figure 17: Prasat Krachap and its surroundings in a LiDAR image

Essentially, the data obtained through traditional archaeological methods only allowed us to draw conclusions concerning the immediate surroundings of Prasat Krachap, but without systematic fieldwalking surveys covering a larger area; the patchy data did not form a consistent, comprehensive picture. The LiDAR data, on the other hand, highlighted the anthropogenic environmental changes that, together with the archaeological and historical sources, shed new light on our previous notions concerning Koh Ker and the environment of Prasat Krachap (Figure 17).

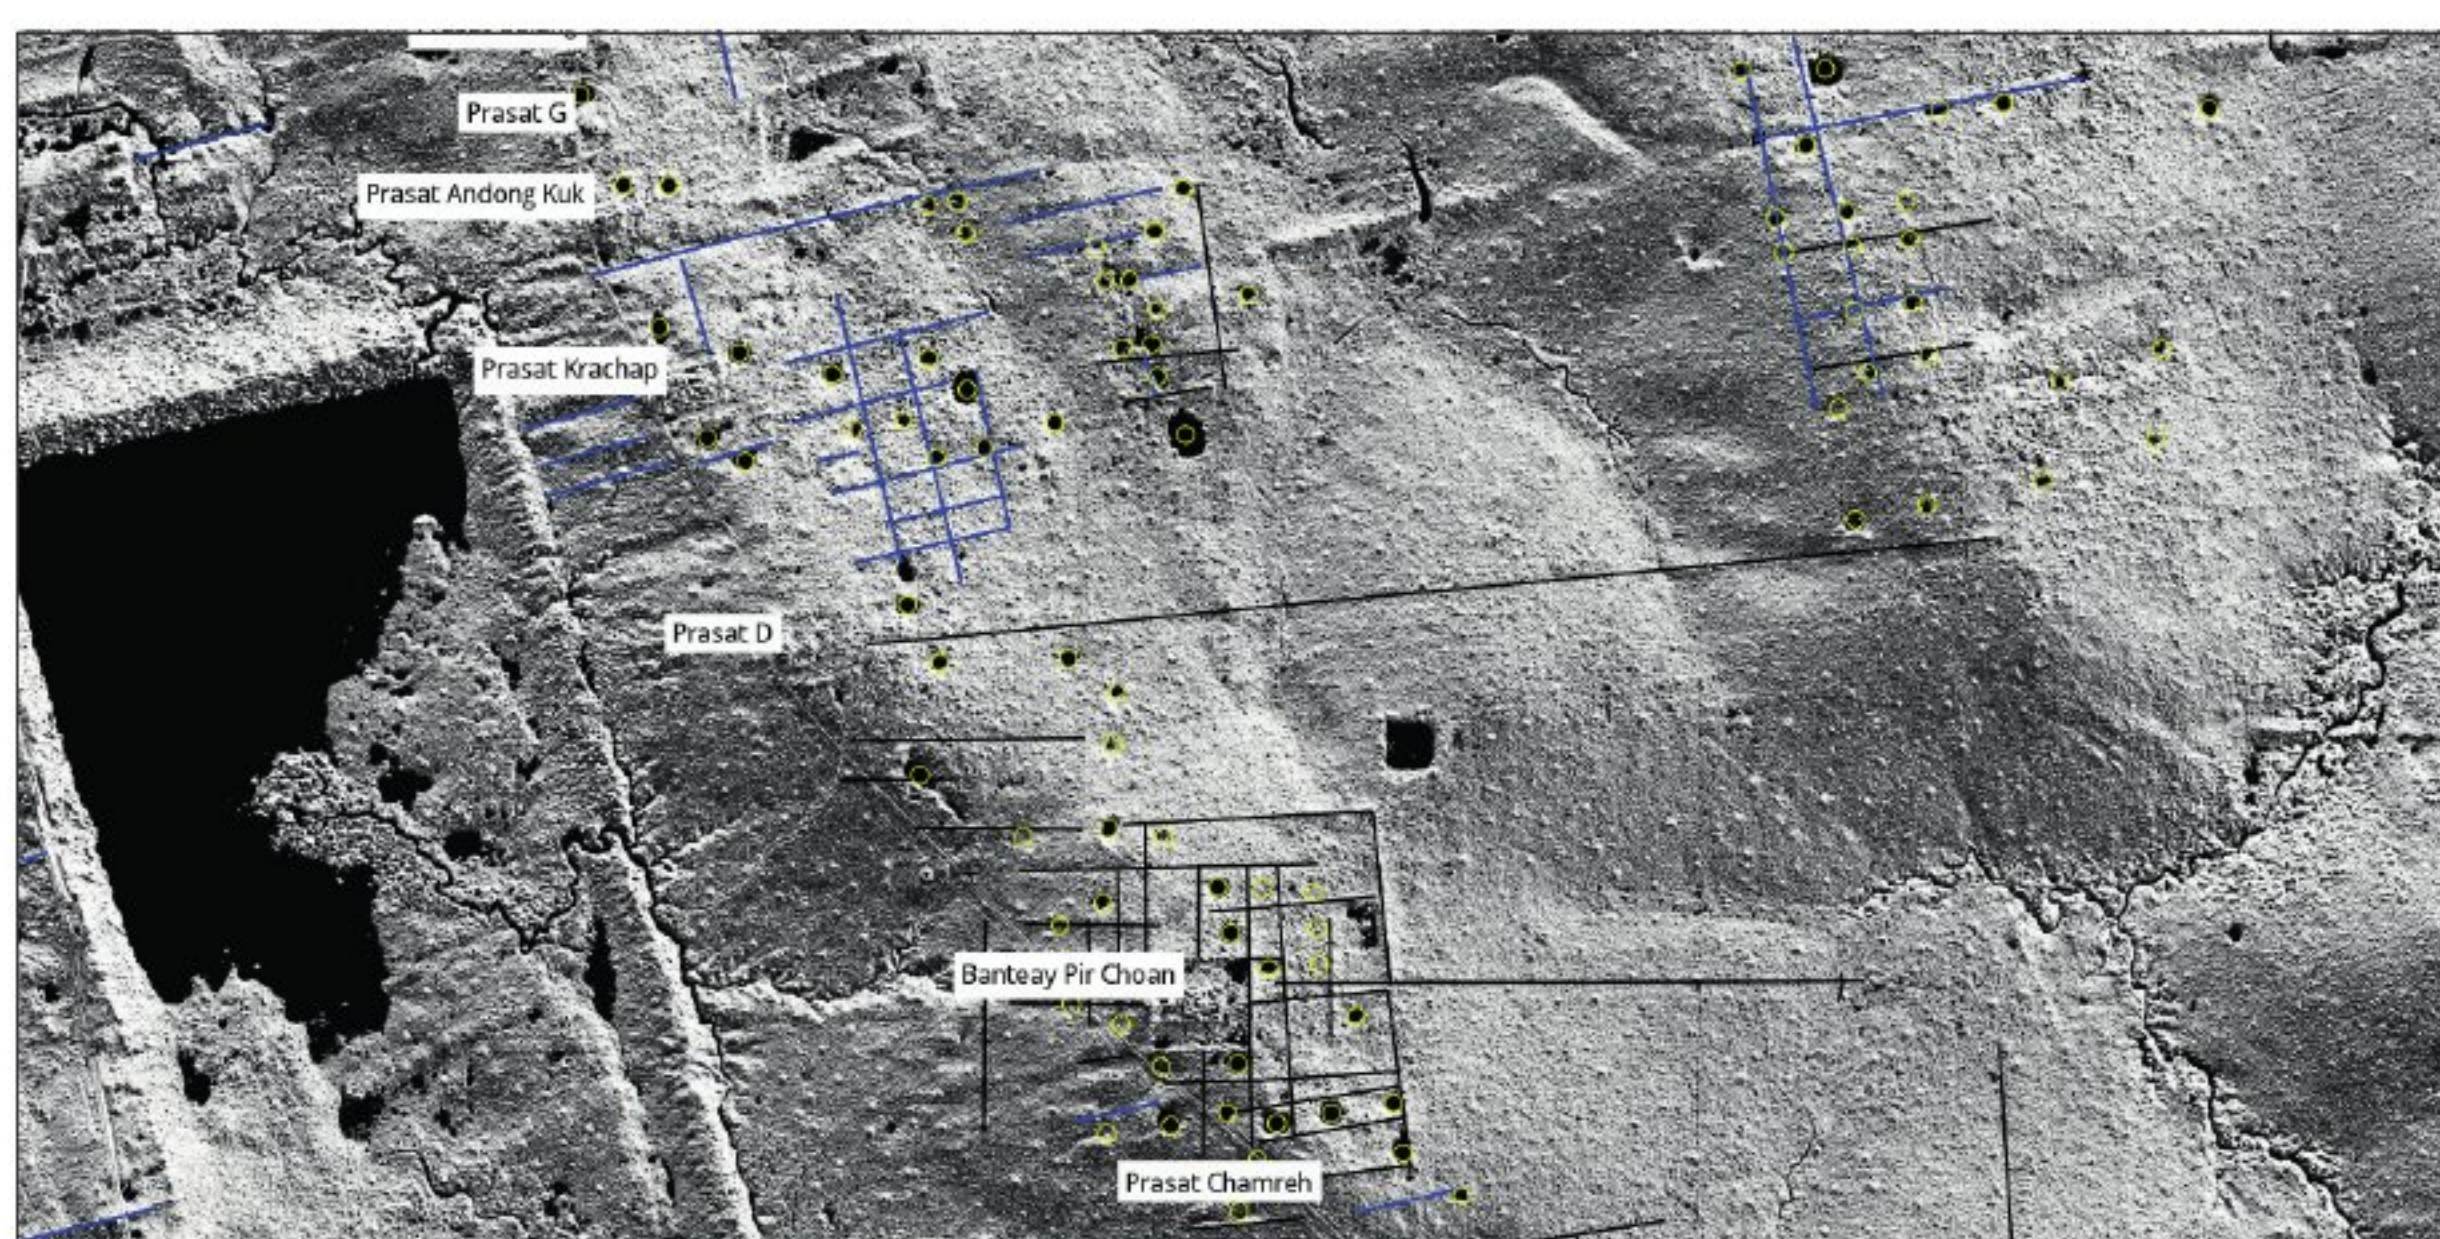
Figure 18: Insular fragments of settlements and small water reservoirs in the LiDAR image

interpreting the anthropogenic environment clearly identified in space and its interconnections (Figure 18).

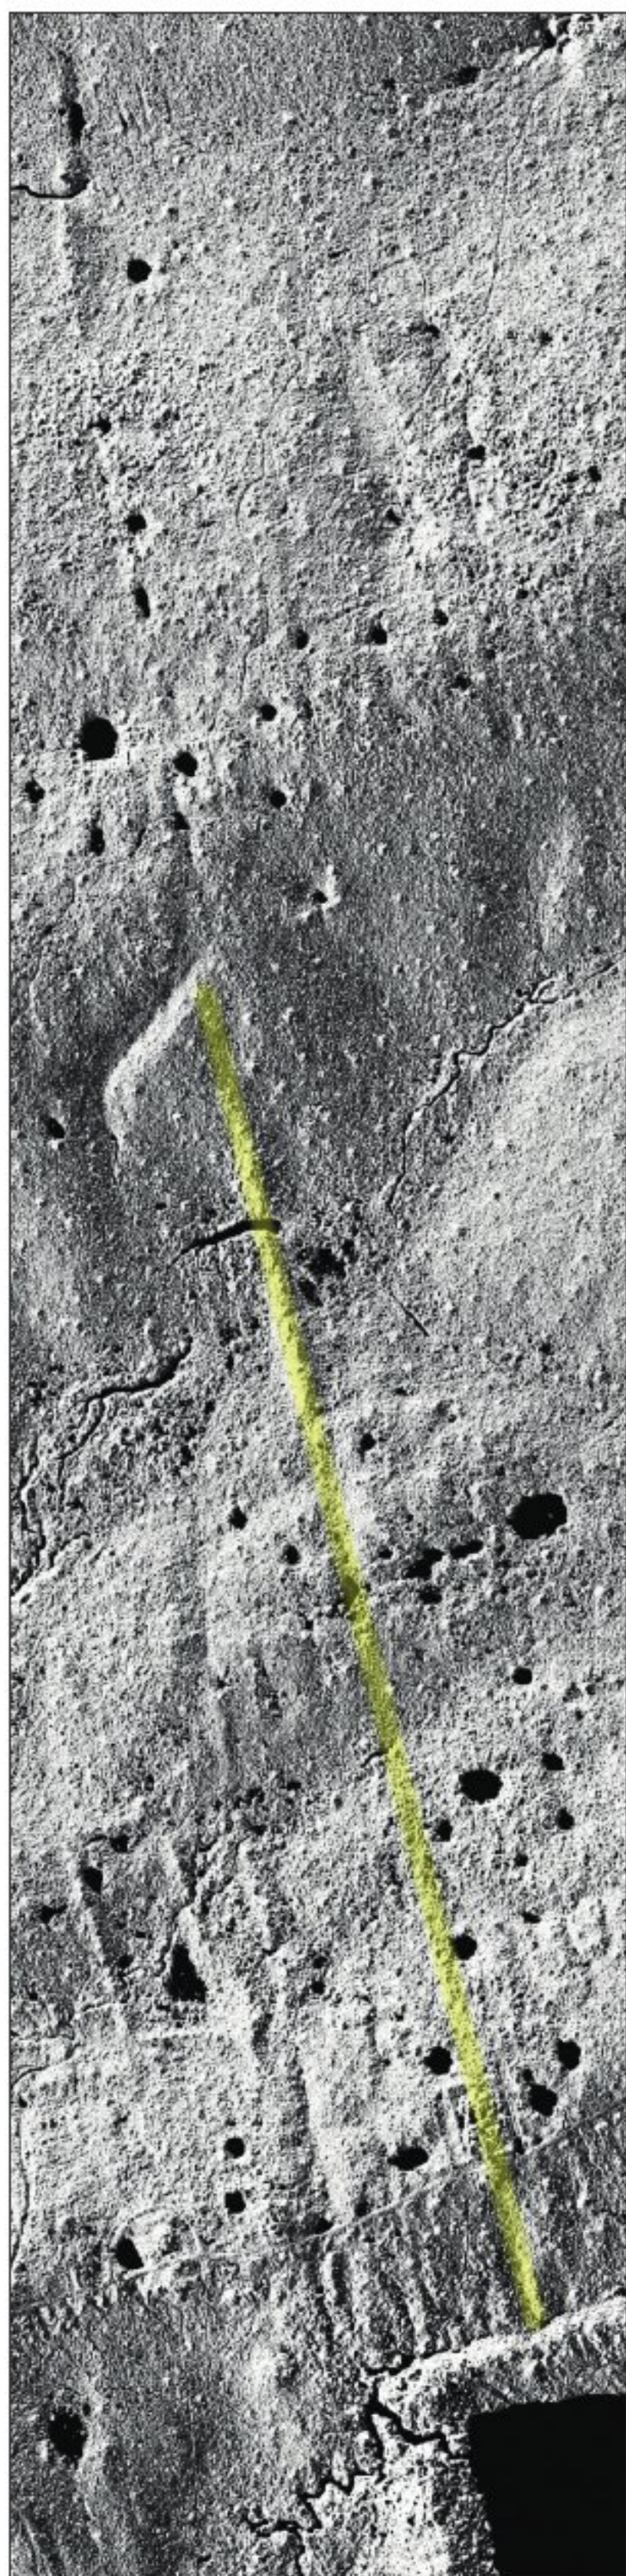
Figure 19: The road aligned with the east-west axis of Prasat Krachap in the Lidar image

Based on available data, our interest focussed on the linear (road?) structure that crosses the east-west axis of the temple (Figure 19). The imaging data suggests that the settlements that once surrounded Prasat Krachap may have lain principally on an east-west line, and clearly connect the temple with the Rahal reservoir. The anthropogenic character and level of construction of that east-west linear system was clear from the LiDAR images, too. In 2011 we succeeded in excavating a building opposite the eastern gate of the temple and the remains of a set of steps on the same axis, towards the Rahal (BELÉNYESY 2013, pp. 29-24). Consequently, we assumed that at one time there had been an attractive link between the water reservoir and Prasat Krachap, and we began to identify it in June 2014.

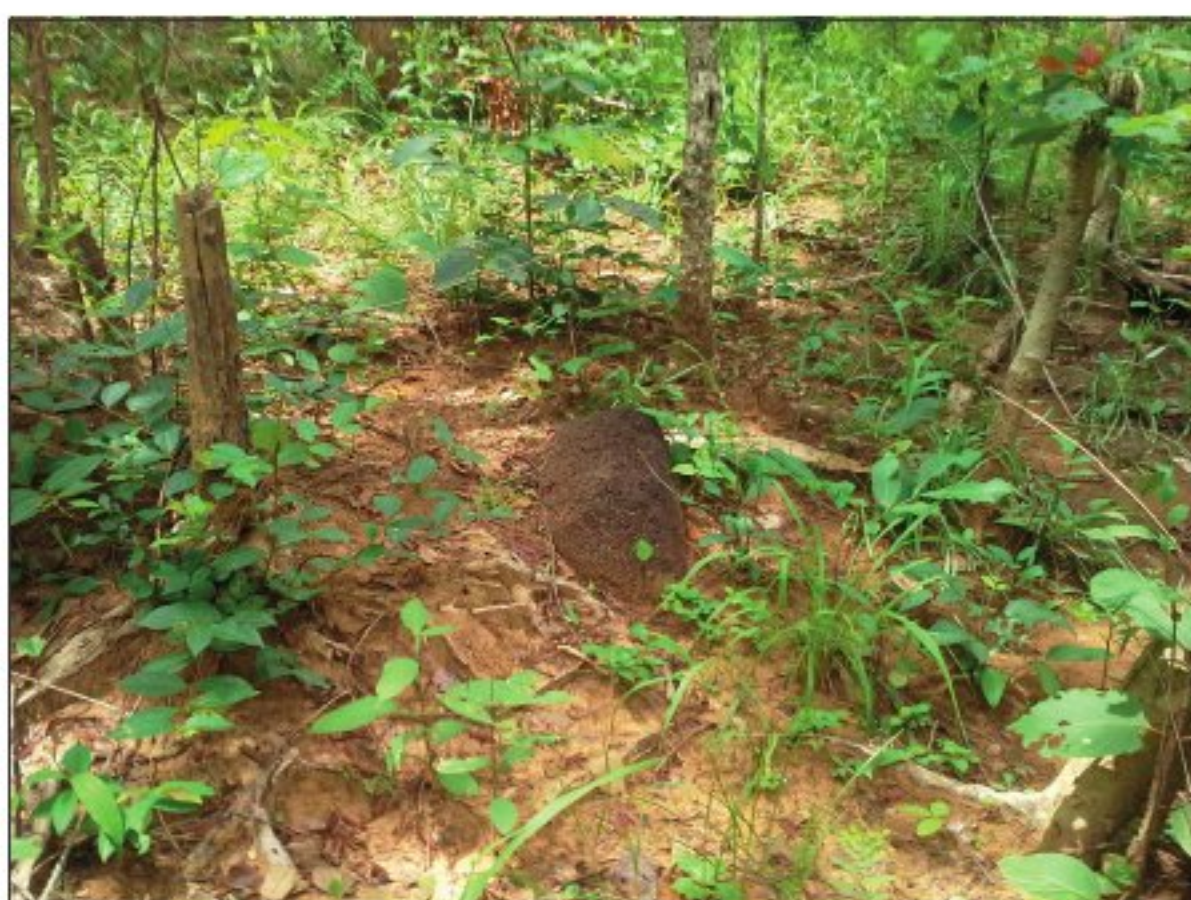
Figure 20: The curb of the former road made from carved blocks of laterite in the forested area between the Rahal and Prasat Krachap

Although the growing season did not favour fieldwalking surveys, in the forest between Prasat Krachap and the Rahal we managed to identify the remains of an almost 5-metre-wide representative road lined with laterite blocks along a length of 180m (Figure 20). Some of the large laterite blocks had carved cavities in their tops for wooden pillars (Figure 21). The contour of the surface where the road met the western embankment of the Rahal indicated a terrace construction, near which we found the remains of a lion carved from sandstone (Figure 22). Whilst fieldwalking, we endeavoured to examine all traces of anthropogenic intervention and consequently found signs of stone quarrying at a sandstone outcrop a short distance from the axis of the road (Figure 23).

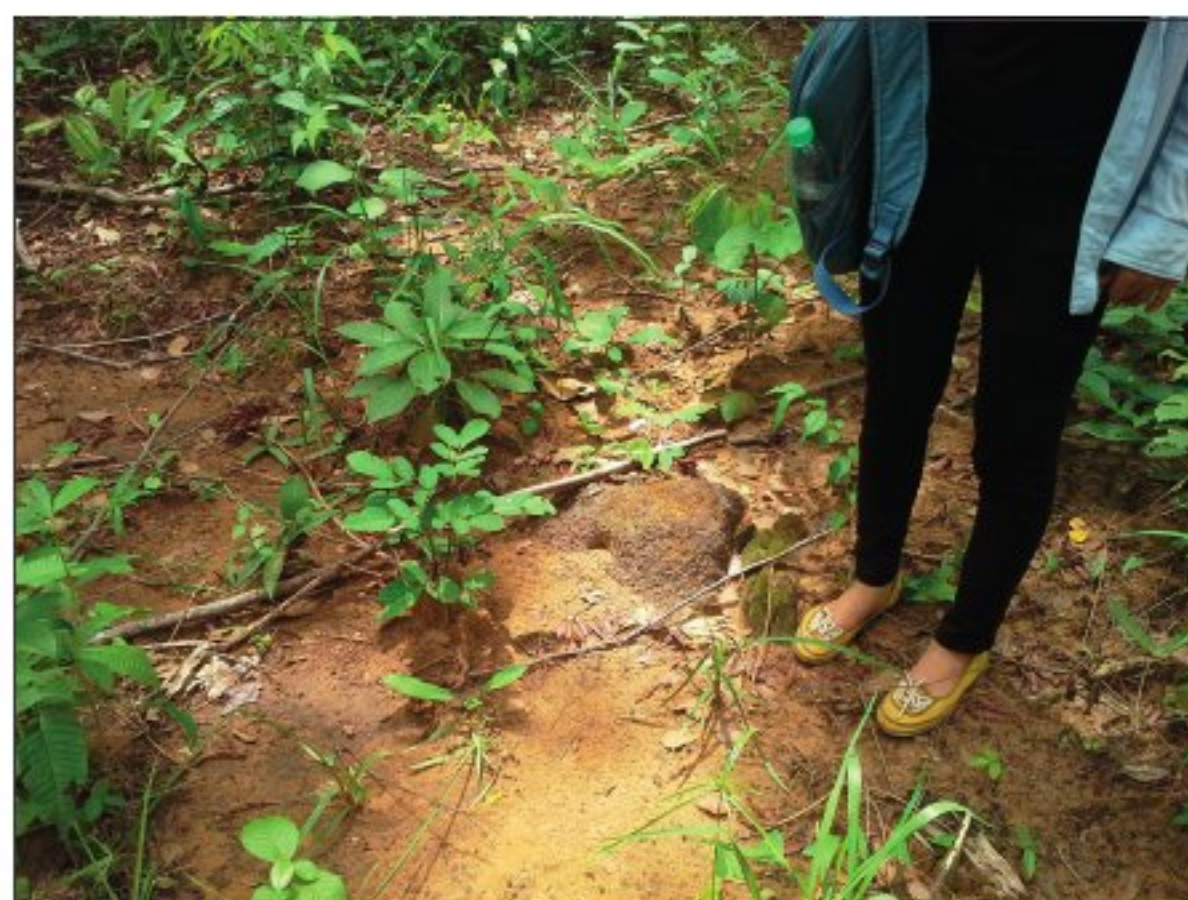
Figure 21: The curb of the former road made from carved blocks of laterite in the forested area between the Rahal and Prasat Krachap

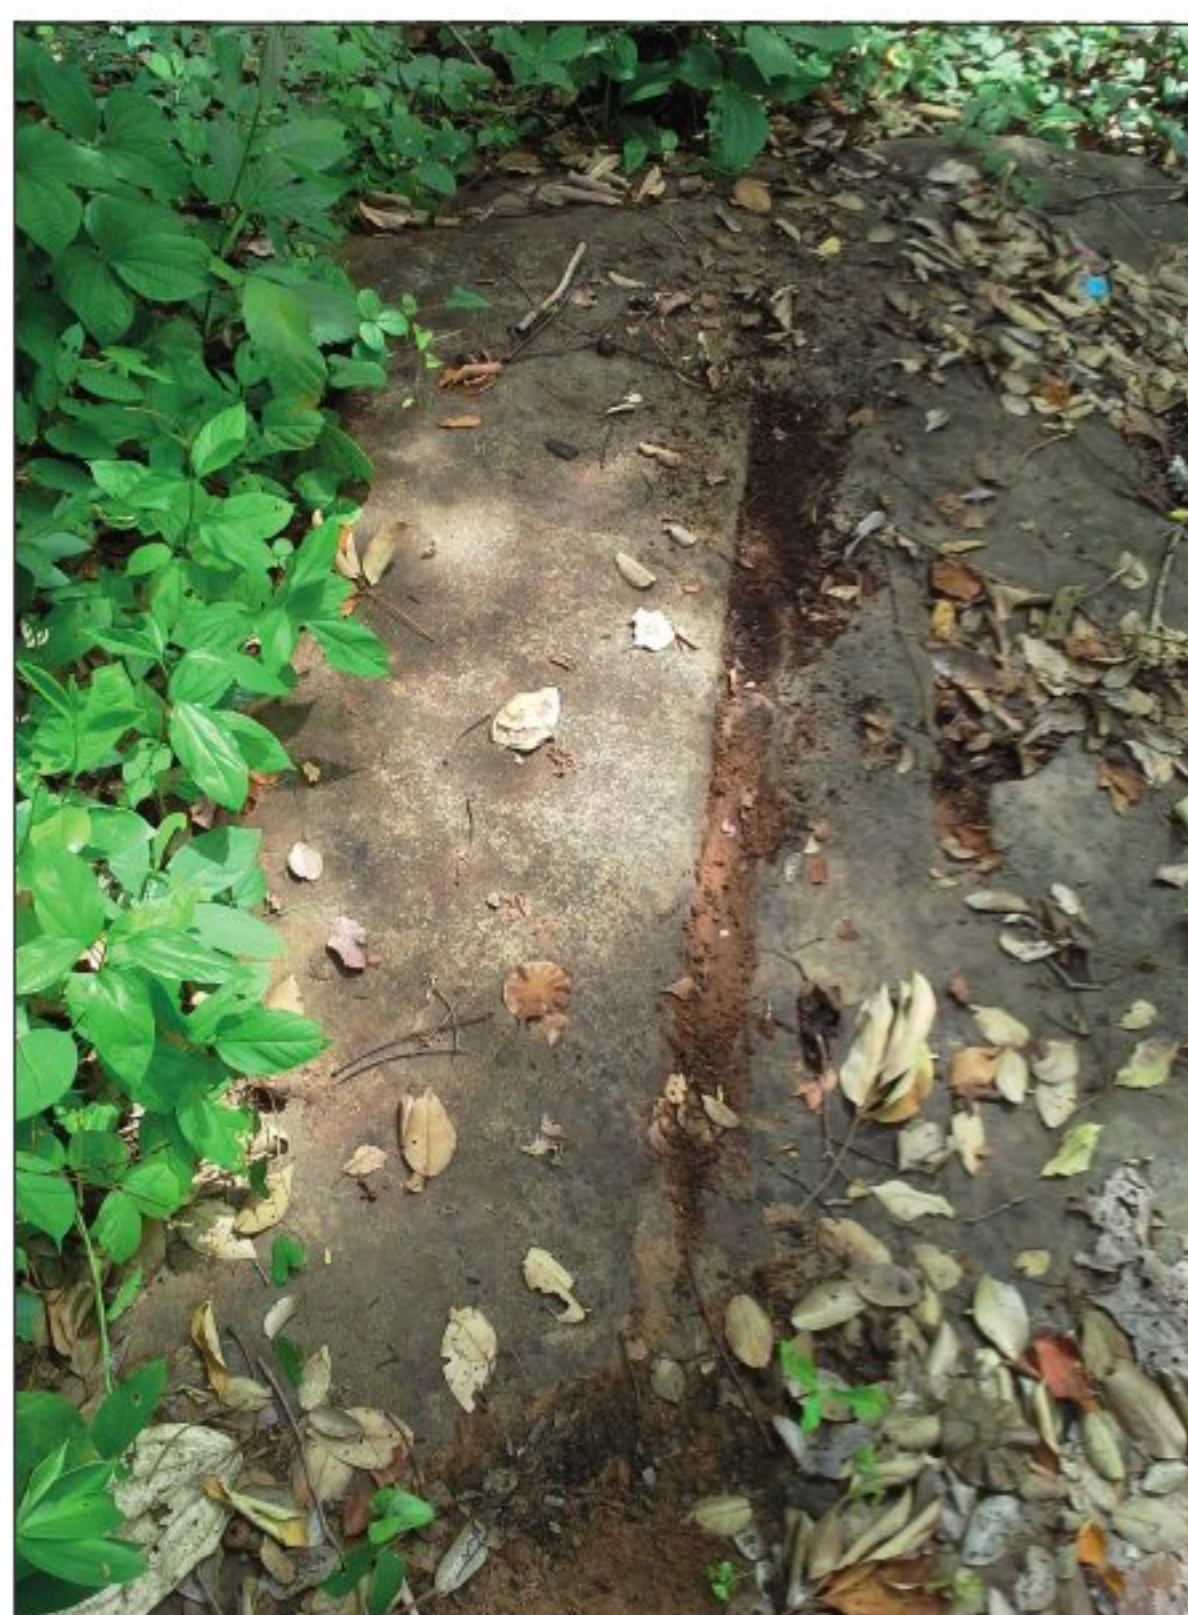
Figure 23: Surface traces of quarrying in the forested area between the Rahal and Prasat Krachap

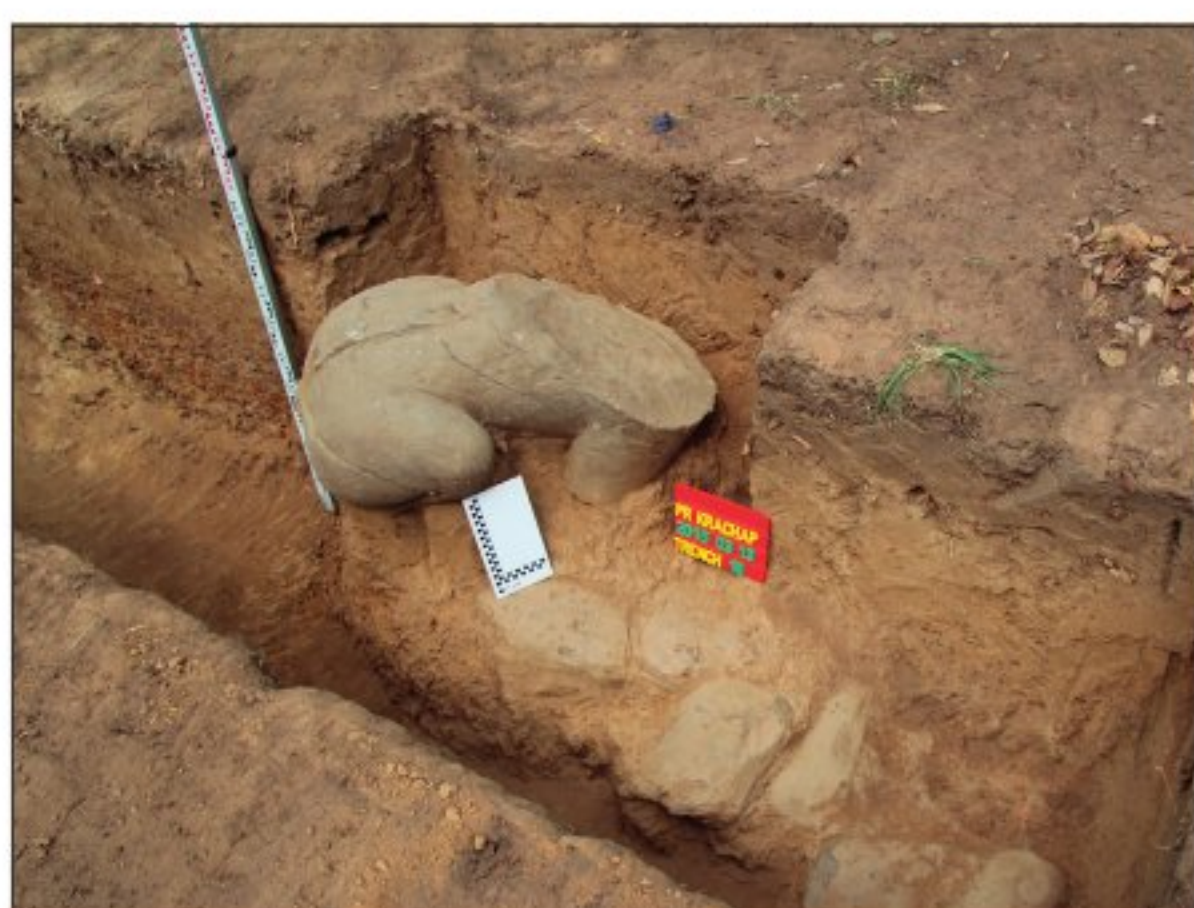
Figure 27: Fragment of a sandstone lion in Trial Trench 18 with remains of the former road

The fragments of the body were in effect found at the original ground level (Figure 27). This indicated that the approx. 4.8m wide road—which slopes slightly to the south, and whose foundation is made of sand, clay and laterite granules—had been paved with irregular slabs of sandstone. This confirmed our previous conjectures concerning the road, when during our previous fieldwalking survey of the forest, where the fallen trees had interfered with its original structure we found several fragments of irregularly shaped sandstone slab (Figure 28). We thought then that they may have been connected with the original paving, but it was at Trial Trench 18 that we first found definitive evidence of the original strata and the *in situ* ground level.

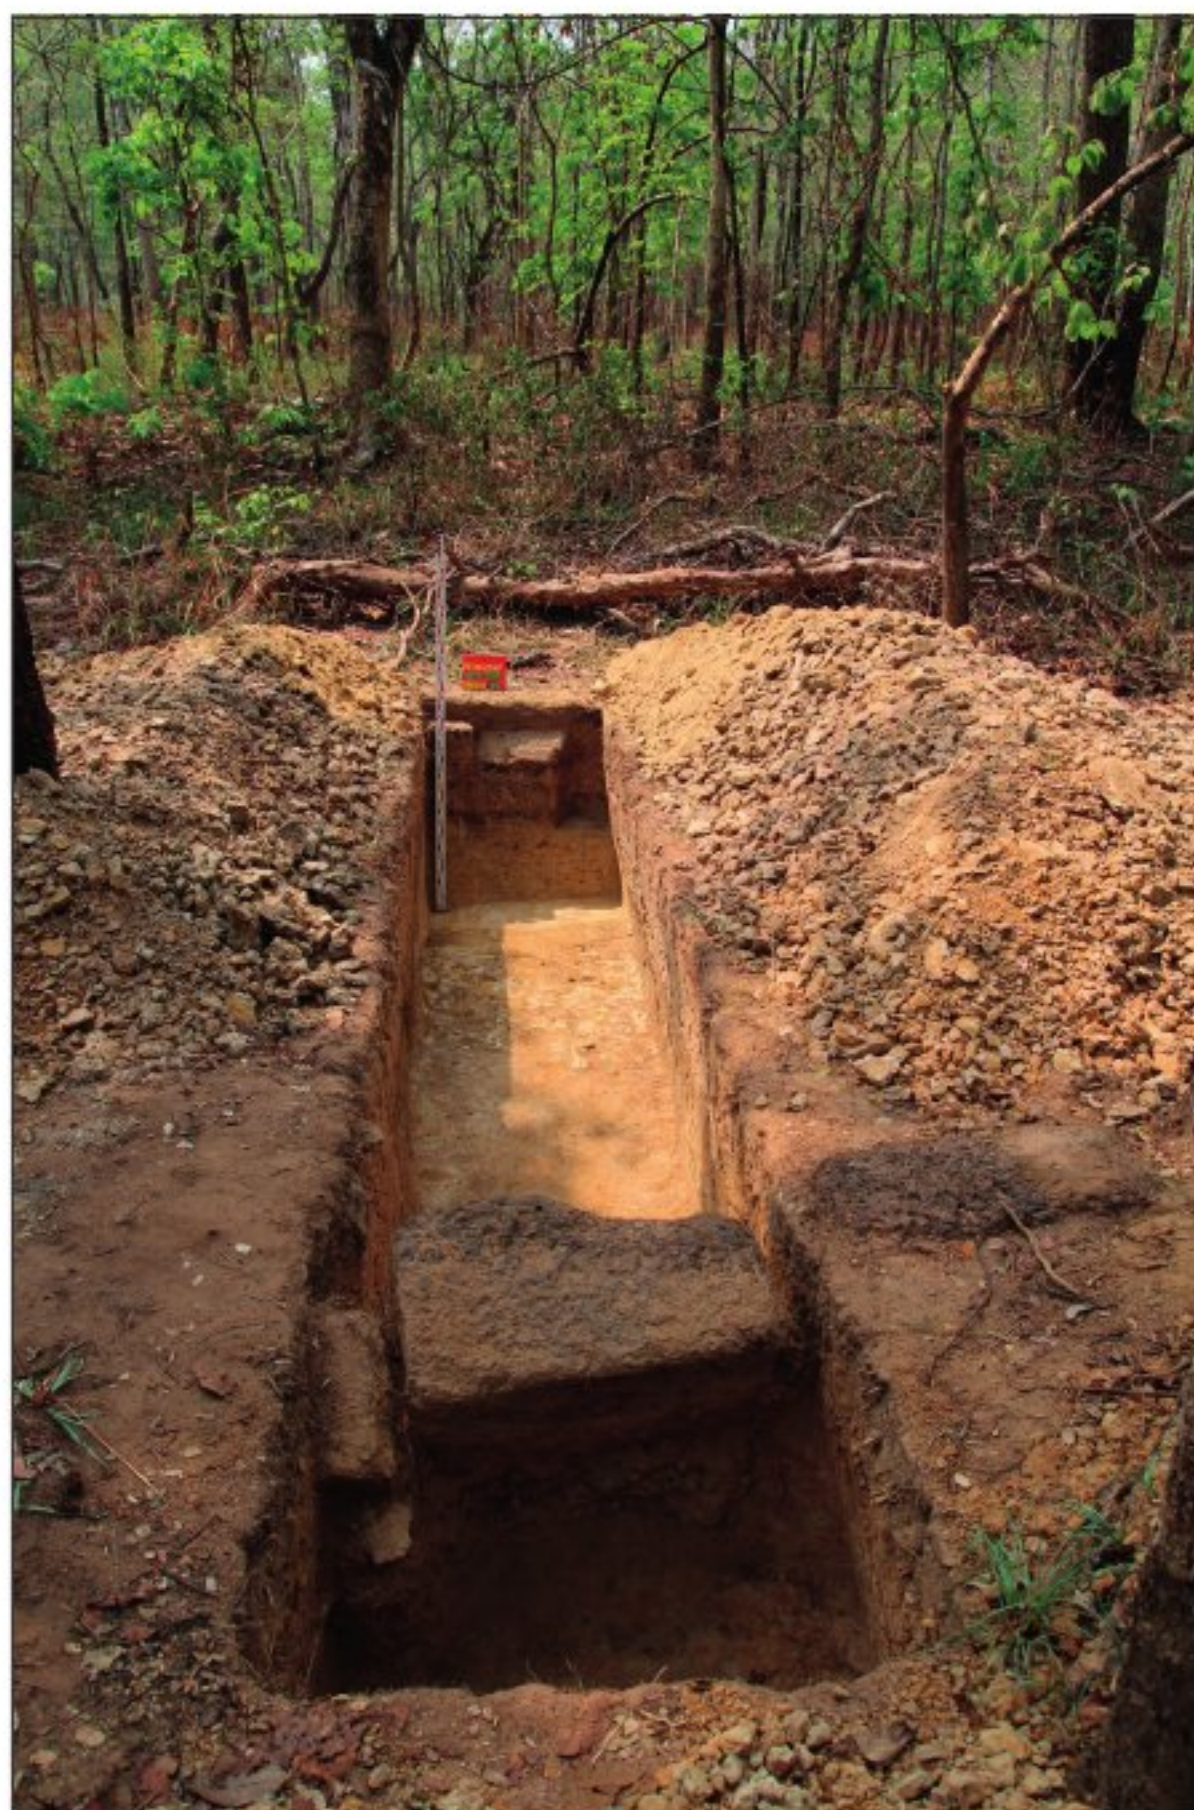
Figure 30: Trial Trench 20 from the north

structures and the road strata in the midsection of the road that runs downwards to the Rahal, we essentially found a set of strata similar to those in Trial Trench 18, with the exception that the original ground level was actually at the surface along that section (figures 29 and 30). The area had been heavily impacted by erosion and other external effects, and apart from a few traces of the original sandstone paving it was almost entirely gone. Similarly, despite the beam receptacles found on the laterite blocks, we found no indication whatsoever of any former upright structures (Figure 31). The only evidence of their probable existence, and the type of covering of the roof, which was probably held by wooden pillars, came in the shape of many roof tiles on both sides of the road. Based on the contours carved into the stone blocks, the columns were spaced at 1.7 m (axis to axis).
