KÁROLY BELÉNYESY, PhD

ARCHAEOLOGICAL EXPLORATION IN KOH KER, PRASAT KRACHAP TEMPLE AND SURROUNDINGS, 2014–2015

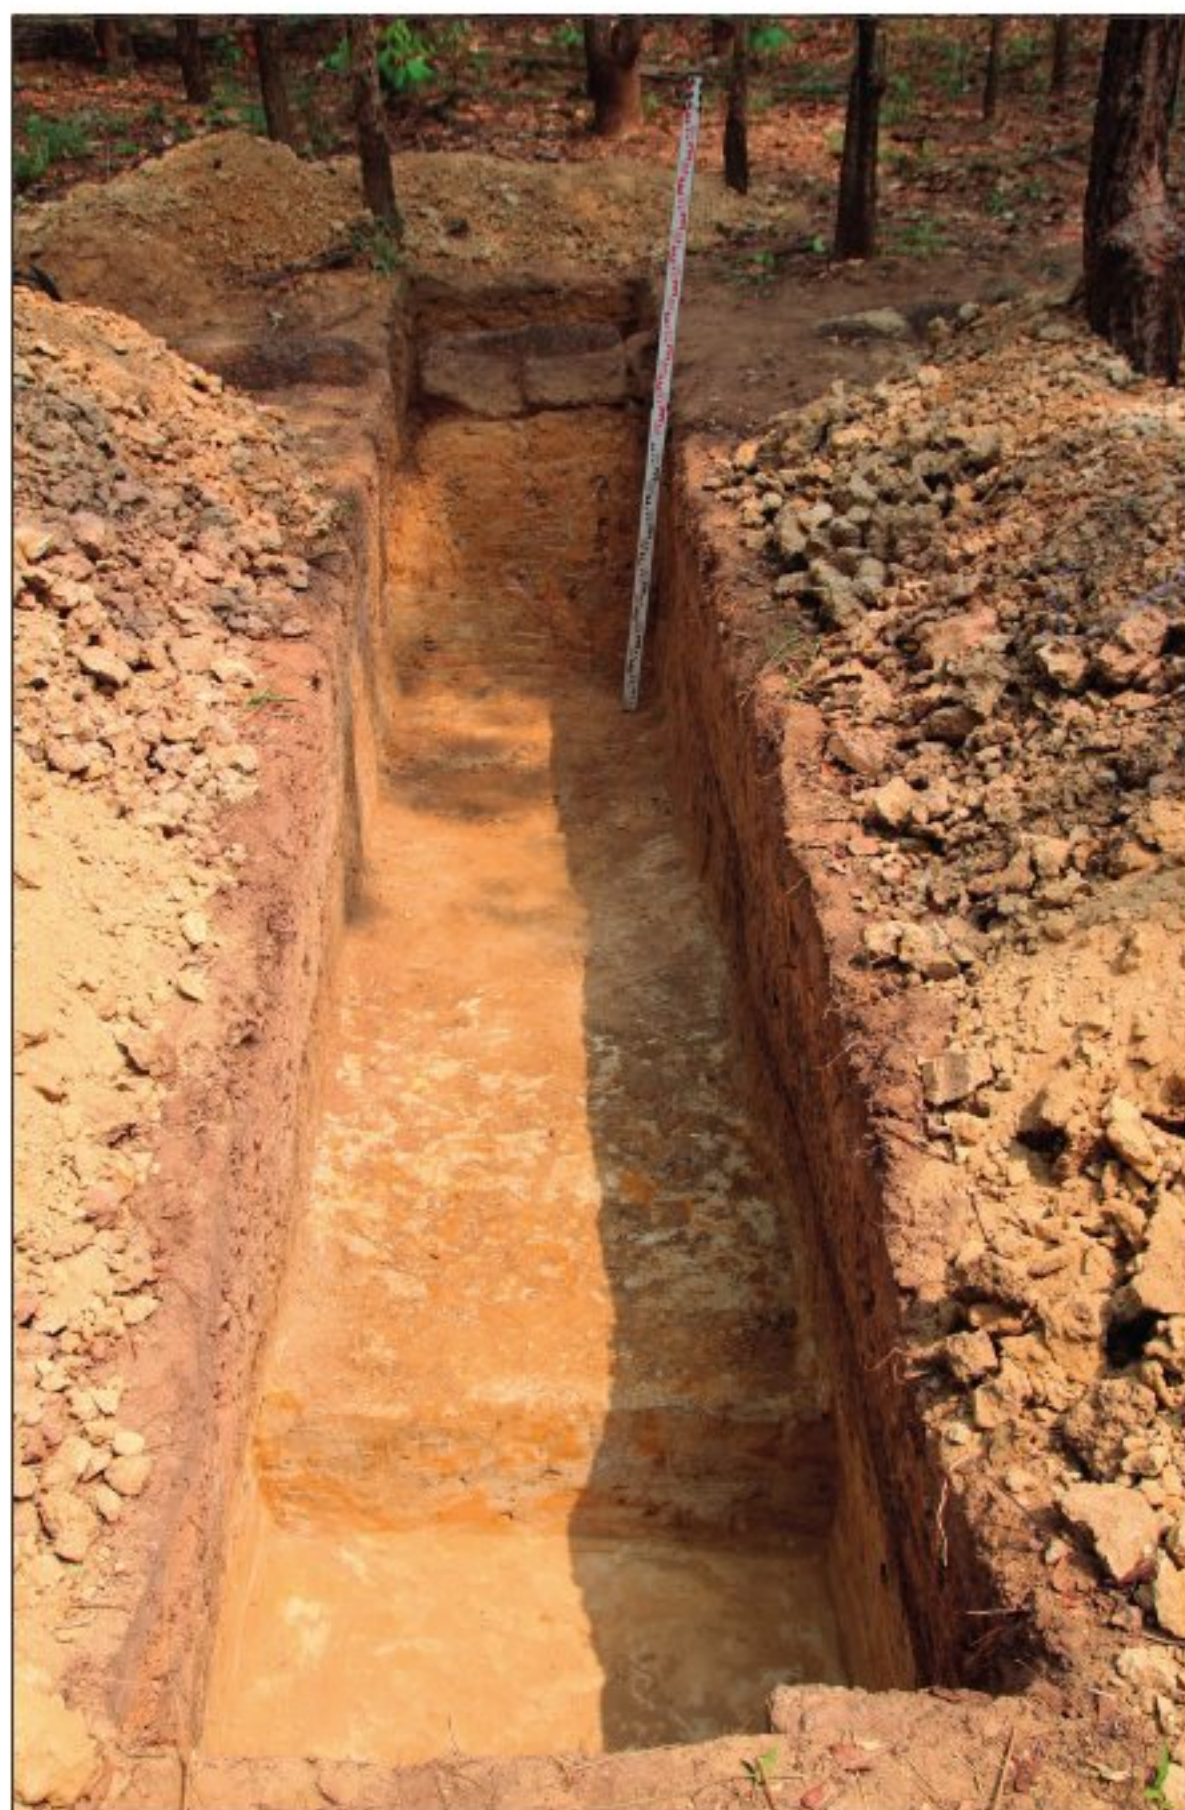
Figure 31: Trial Trench 20 from the south

structures and the road strata in the midsection of the road that runs downwards to the Rahal, we essentially found a set of strata similar to those in Trial Trench 18, with the exception that the original ground level was actually at the surface along that section (figures 29 and 30). The area had been heavily impacted by erosion and other external effects, and apart from a few traces of the original sandstone paving it was almost entirely gone. Similarly, despite the beam receptacles found on the laterite blocks, we found no indication whatsoever of any former upright structures (Figure 31). The only evidence of their probable existence, and the type of covering of the roof, which was probably held by wooden pillars, came in the shape of many roof tiles on both sides of the road. Based on the contours carved into the stone blocks, the columns were spaced at 1.7 m (axis to axis).

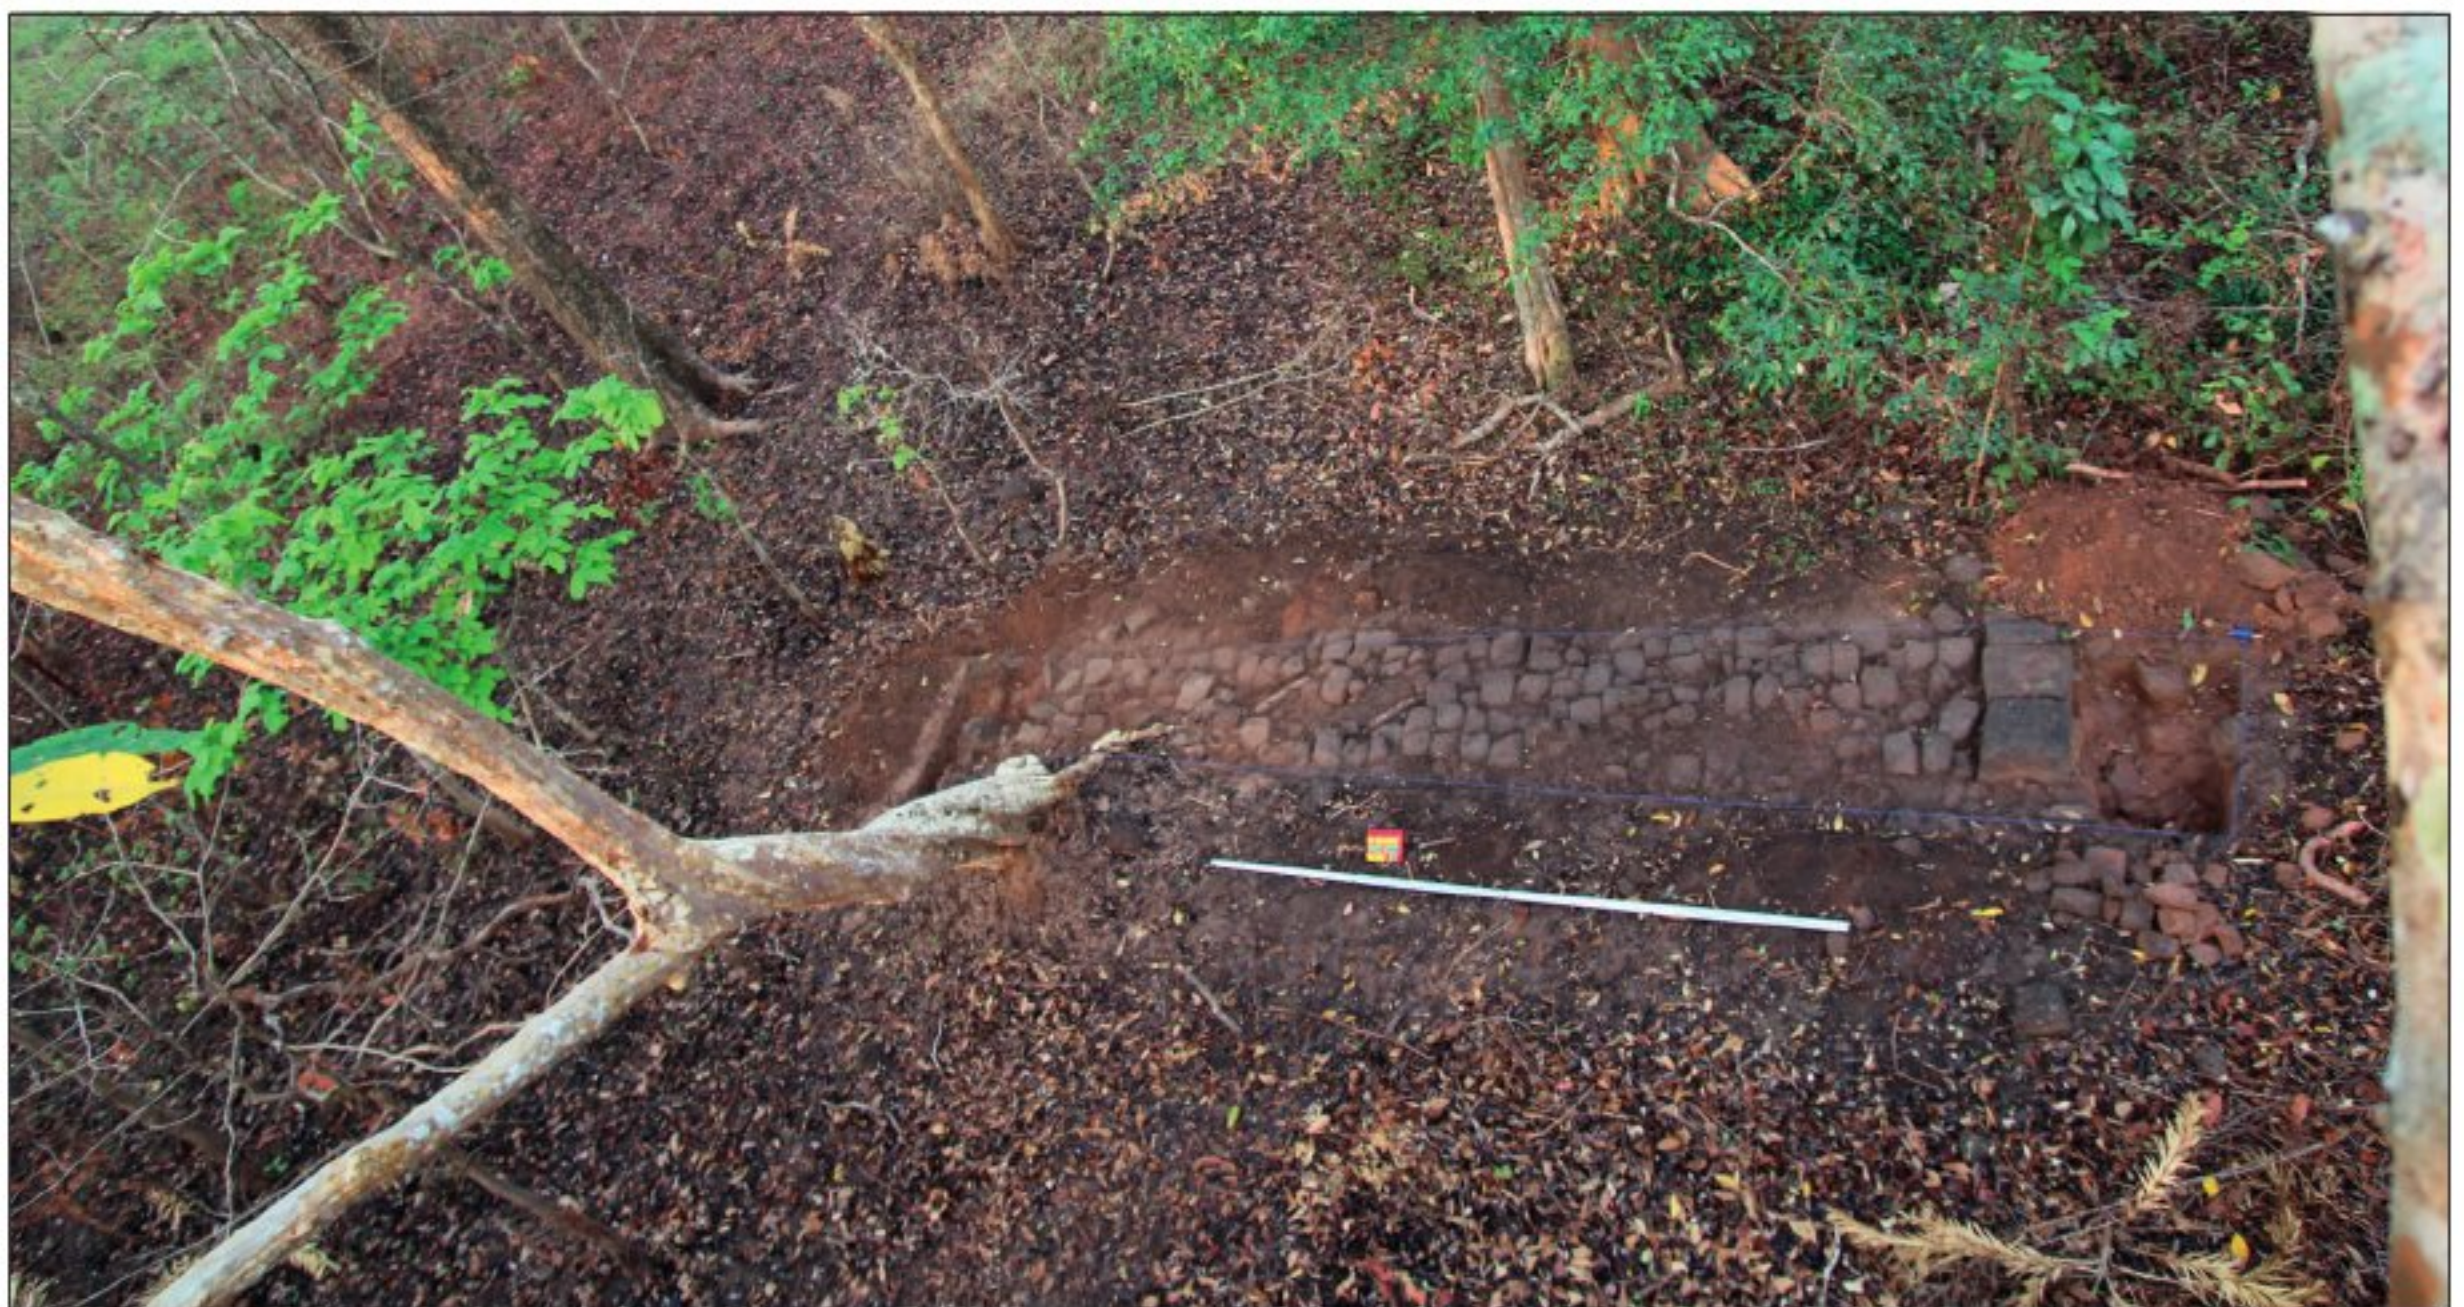
Figure 32: The excavated steps from the terrace

During the site survey in 2014, the outline of a terrace was identified where the road meets the eastern embankment of the Rahal. After clearing the undergrowth, we were unable to test that assumption because the area of the possible terrace had been completely overgrown by trees, thus a genuine survey would also require the felling of large trees. On the other hand, during the clearing of the embankment from the terrace towards the Rahal, we discovered an original, stone construction that is clearly related to the road and the aforementioned terrace (Figure 32).

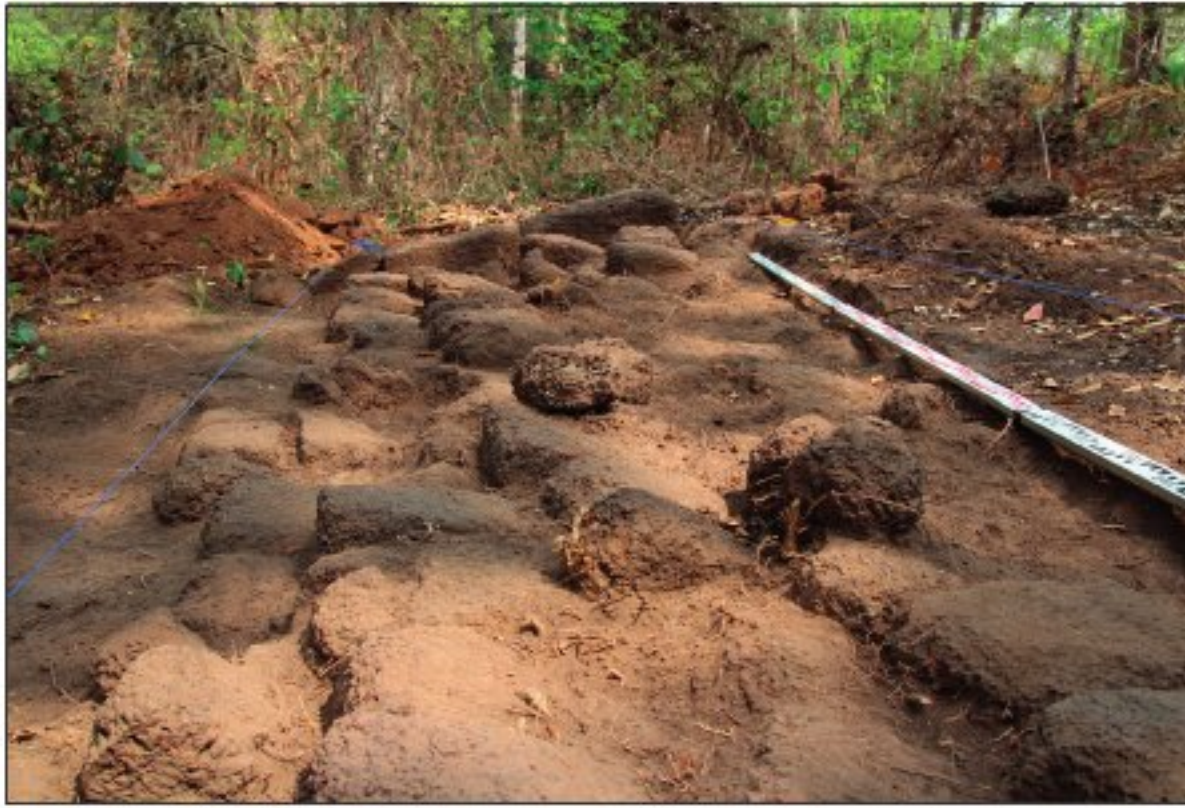
Figure 34: The laterite stone structure of the stairs

As soon as the undergrowth was cleared, the *in situ* remains of a 30 x 15 cm set of steps built from laterite blocks and aligned with the axis of the road became visible, accompanied on the northern side by a much larger skirting made from carved laterite blocks. The same skirting had been damaged to the south by the trees standing there, but the almost 8m width of the steps was still identifiable (figures 33-35).

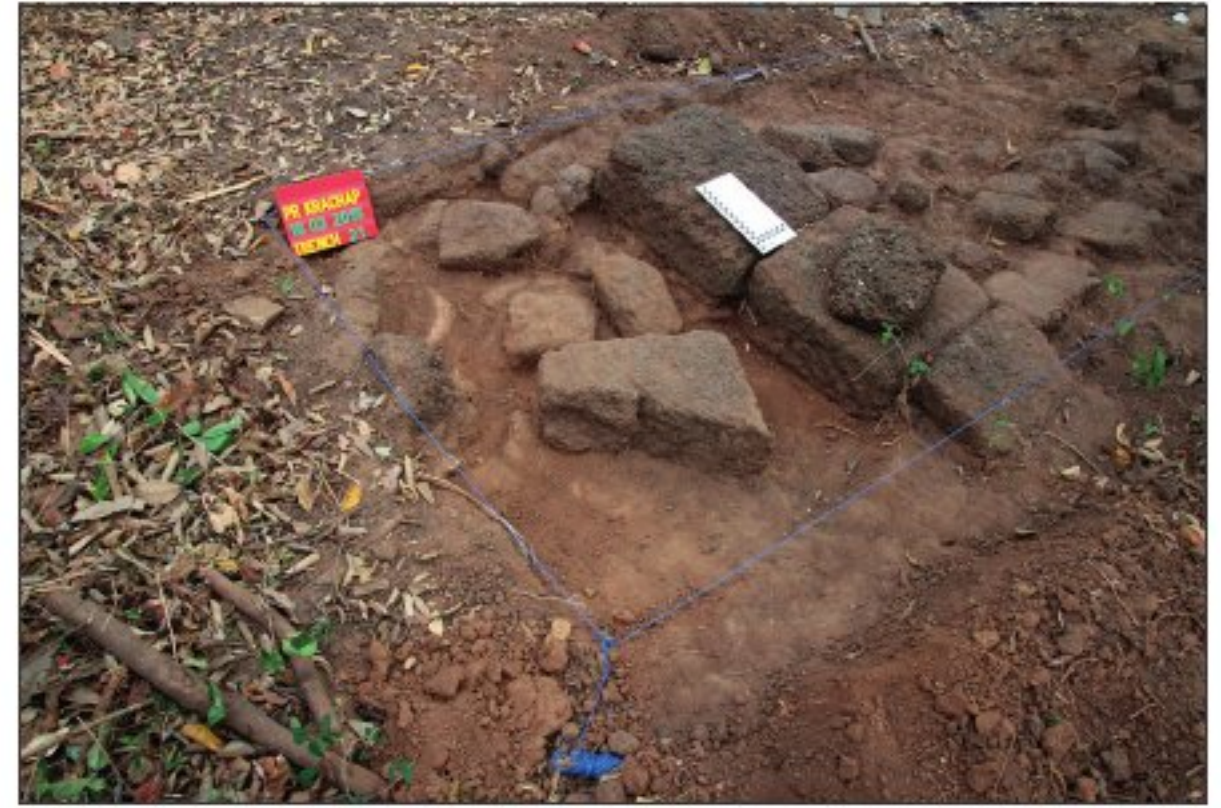
Figure 35: The embankment during excavation

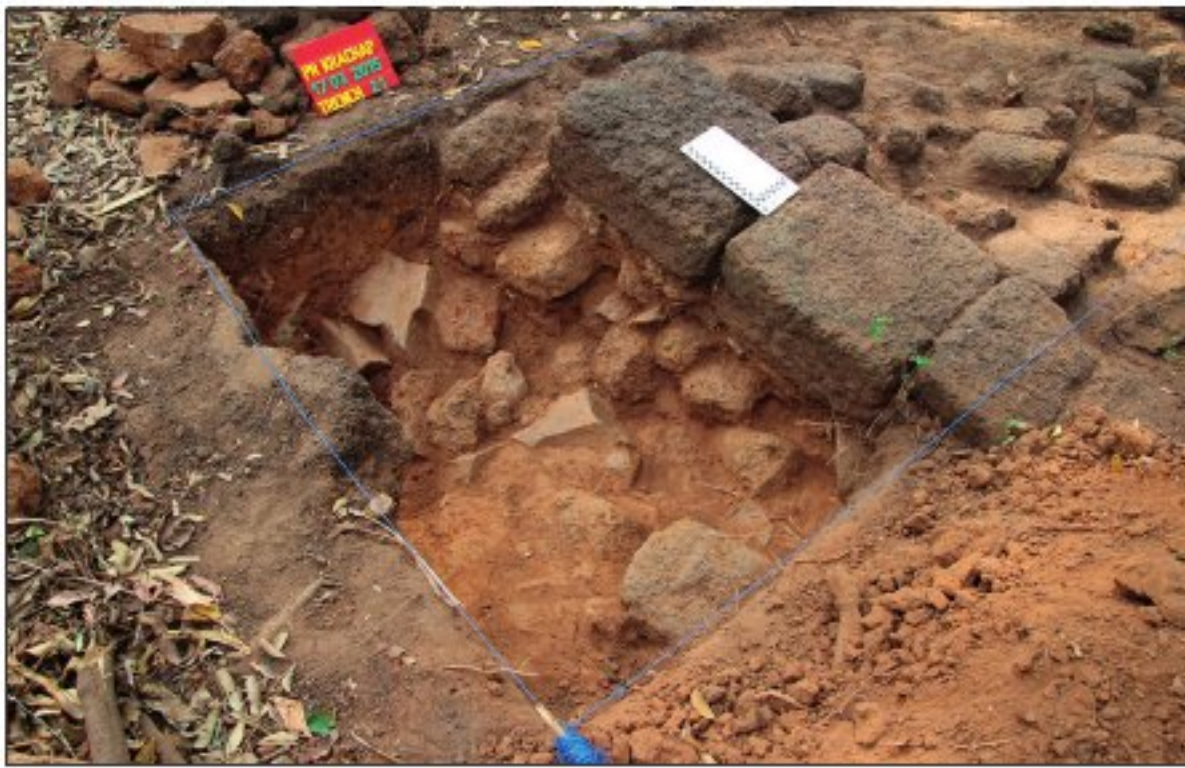
Figure 36: The embankment during excavation

28 the Rahal, we also discovered a small section of the original embankment, built from variously sized laterite and sandstone blocks (Figure 36).

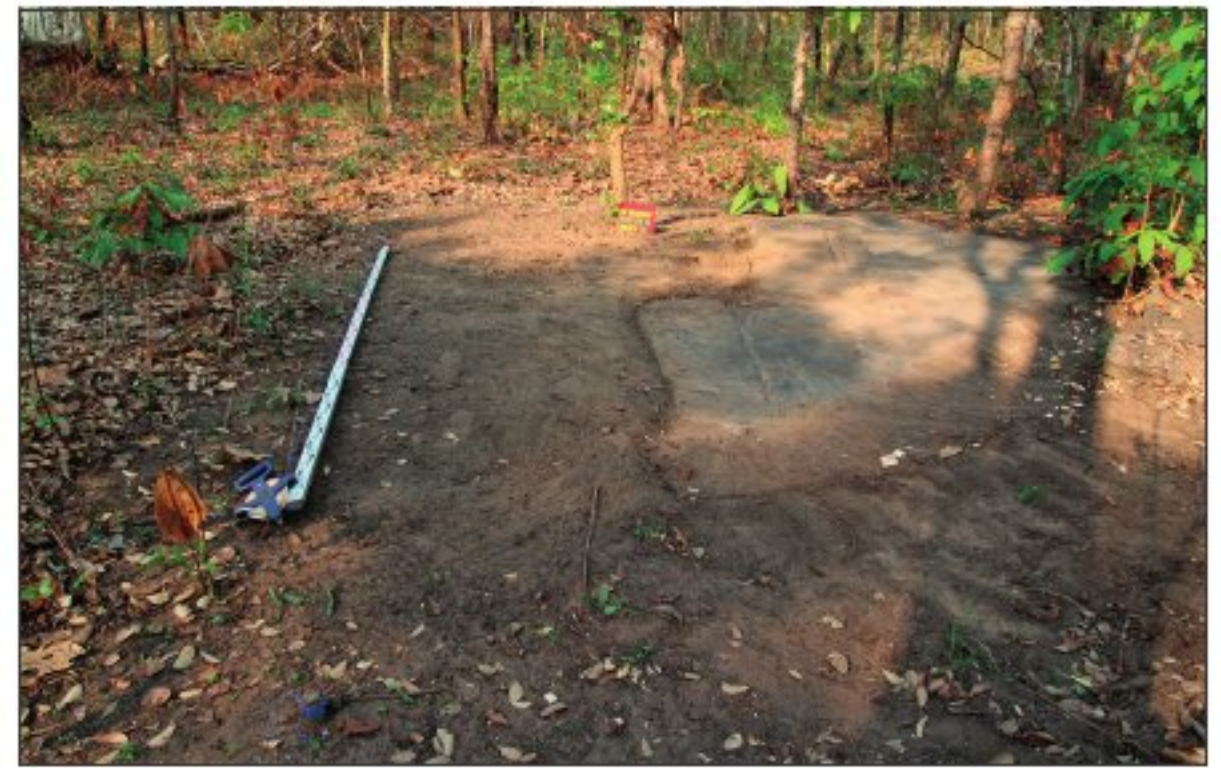
Figure 37: Surface traces of quarrying in Trial Trench 19

Ever since we found them in 2014, we have been planning to perform an archaeological exploration of the area around the traces of stone quarrying discovered not more than 40m from Prasat Krachap. The trench dug in the area was primarily intended to find more evidence of local stone quarrying. We cleared the natural outcropping of sandstone where the traces of quarrying had been observed, and once those were documented, we excavated the southern side of the man-made surface over an area of 5 x 2.5m (figures 37 and 38).

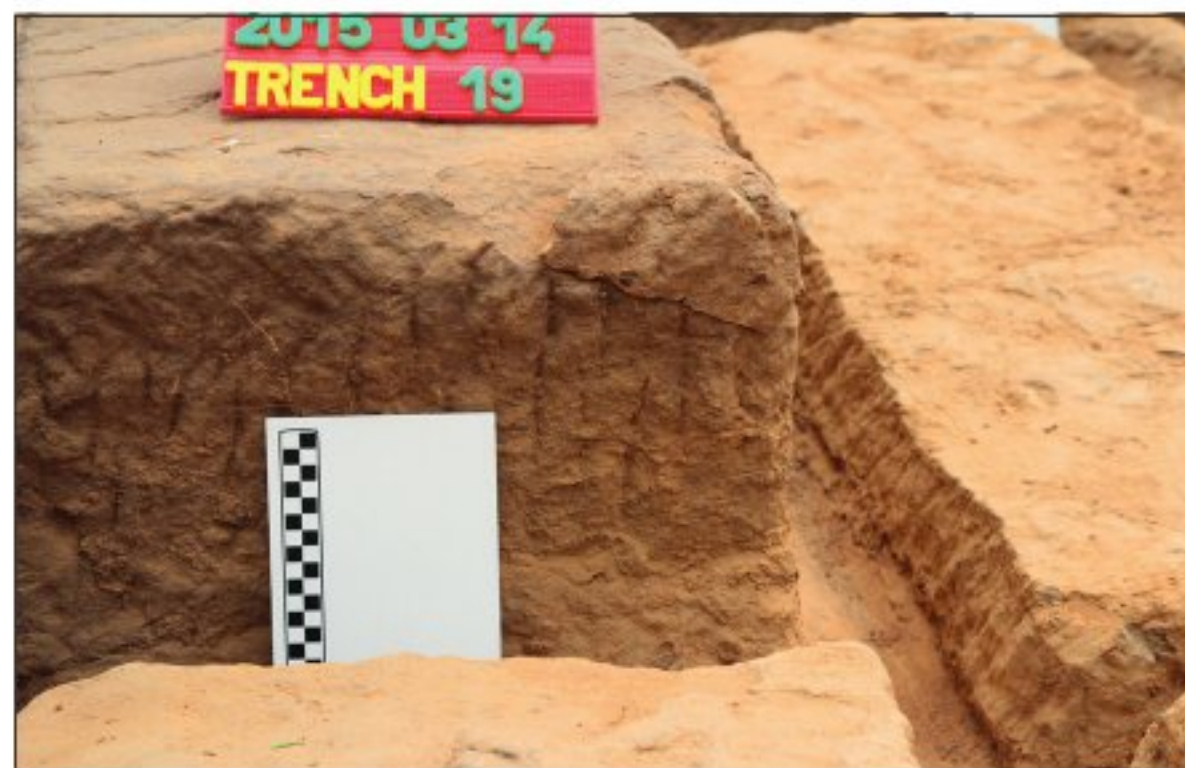
Figure 39: Trial Trench 19 during excavation, with traces of quarrying

In the course of that work, we found traces of the cutting of four 50 x 150 cm stone slabs and preparations for the cutting of two more of a similar size on the original sandstone surface. In the lines around the slabs, we also found traces left by the metal quarrying tools used (figures 39-41). During the excavation there, it was also established that the quarry had been abandoned and systematically refilled after use. The cuts in the stone were filled with the same material made of laterite granules mixed with fragments of roof tiles that had been found repeatedly during the excavation of the road and the foundation layers of buildings.

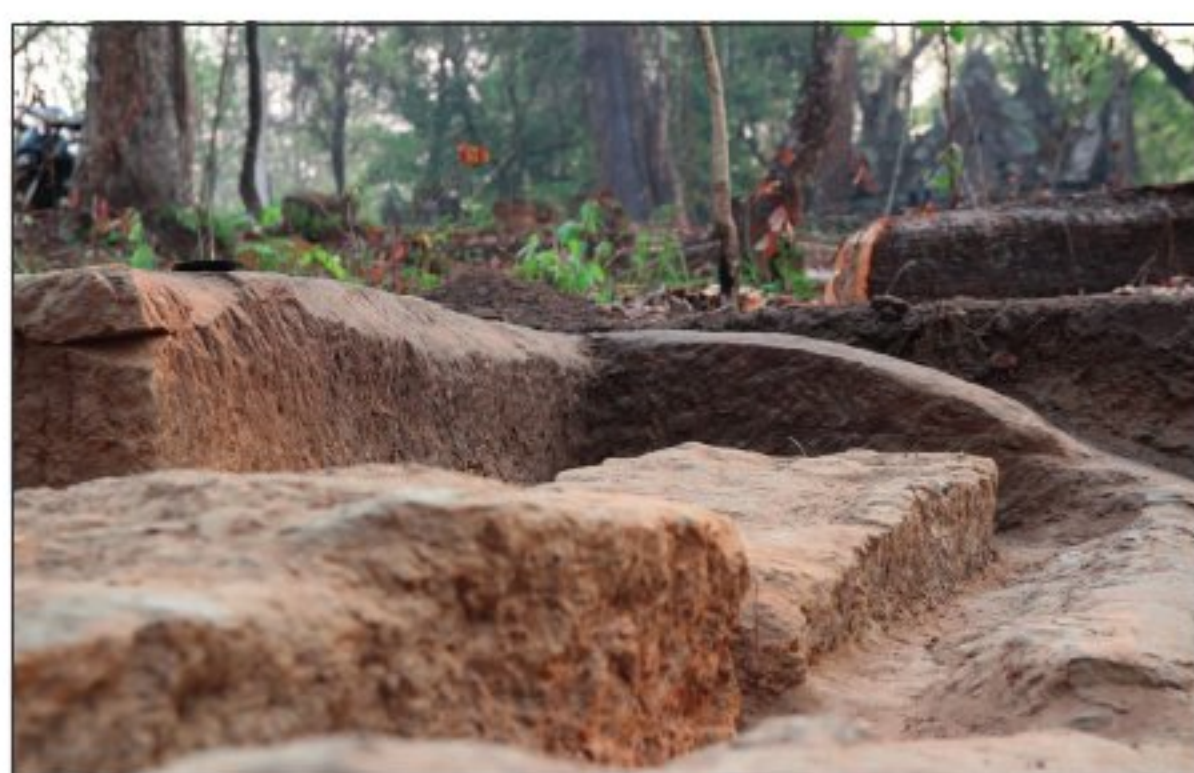
Figure 40: Trial Trench 19 during excavation, with traces of quarrying

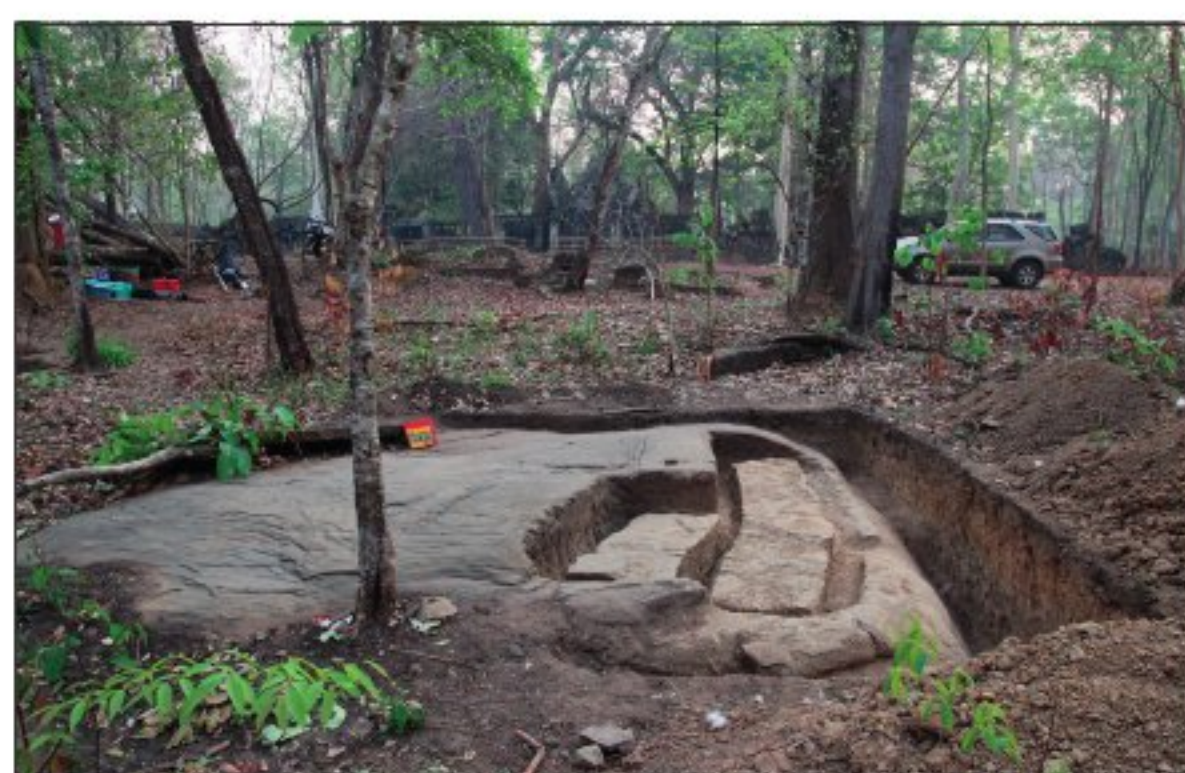
Figure 41: Trial Trench 19 fully excavated, with Prasat Krachap in the background

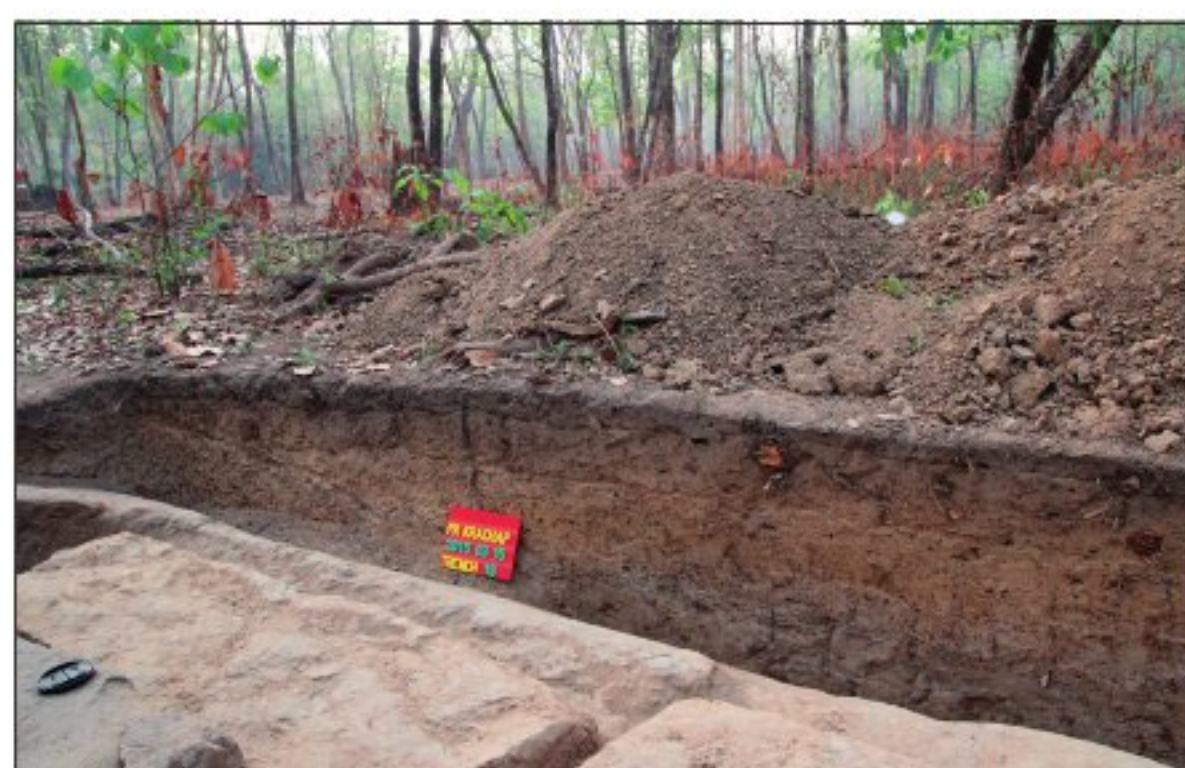
Figure 42: Southern cross section of the fully excavated Trial Trench 19

stone for the building of Prasat Krachap was systematically covered over as part of a larger landscaping effort (Photo 42). So we are correct in assuming that in the course of the construction of the temple, along with the conscious use of the features of the original natural environment (Figure 43), it was also in some places transformed. Thus even radical transformations of the original natural landscape are possible as far as the environments of both Prasat Krachap and other temples are concerned.
